U.S. Department
of Transportation
**National Highway
Traffic Safety
Administration**

DOT HS 811 573

January 2012

Chevrolet Volt Battery Incident Overview Report

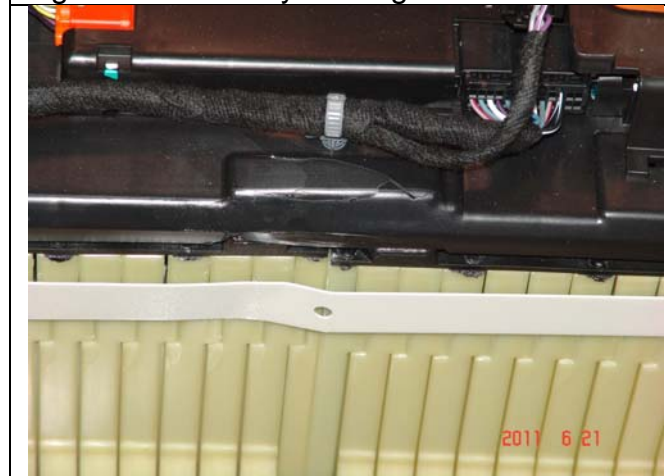
Figure 2.01 Battery Damage from Test 7385

In the test conducted with the 50th percentile male dummy on April 20, 2011, there was minor intrusion into the battery case but little if any damage to the battery and battery cooling system. A photograph of the damage is shown in Figure 2.01. There was no damage to the batteries in either of the next two tests; the side-moving deformable barrier test conducted on May 6, 2011 or the frontal crash test conducted on May 11, 2011. None of the vehicles tested in these first three tests experienced a thermal event at any time during or after the test.

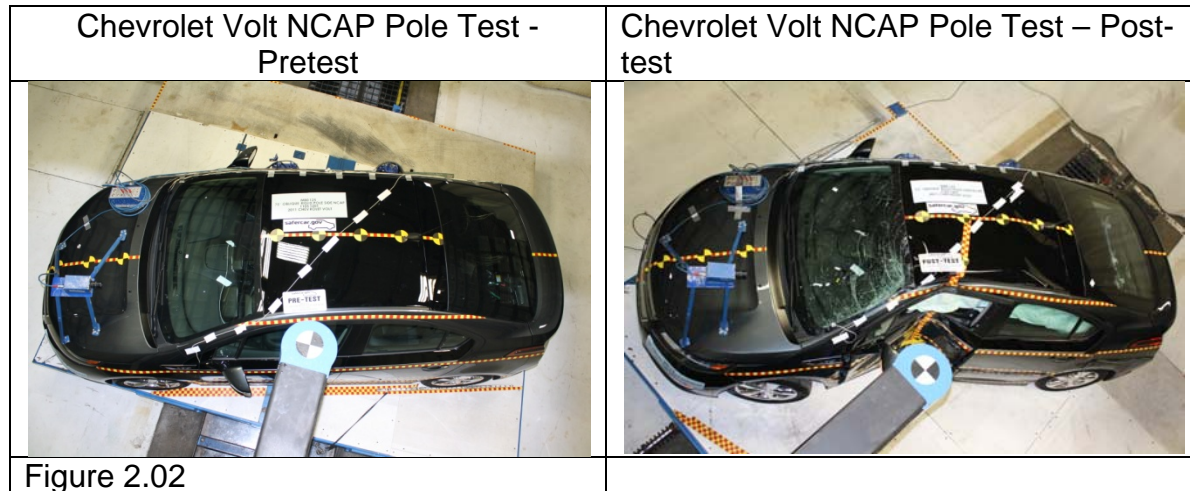
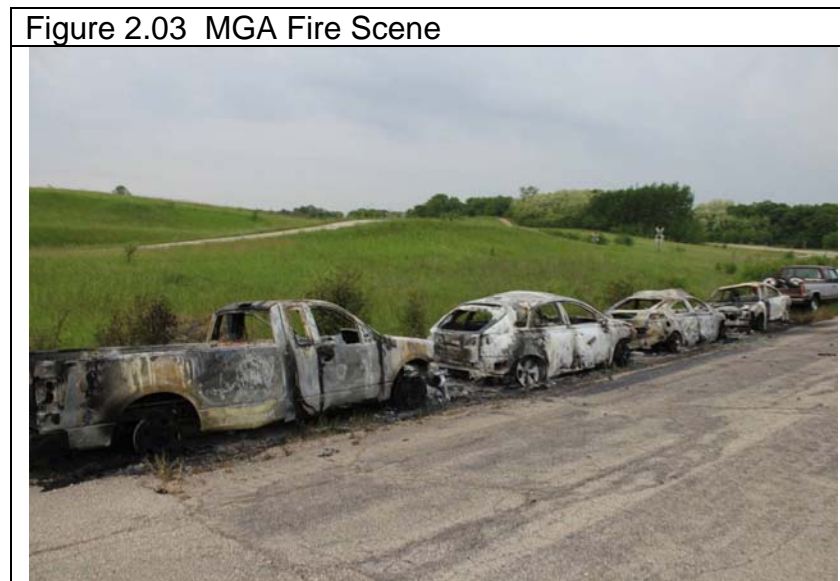
During the NCAP pole test conducted with the 5th percentile female dummy on May 12, 2011 at the MGA test facility (Figure 2.02), the battery was physically damaged by part of the vehicle structure that intruded into the side of the battery. This intrusion, not easily detected by visual inspection, went unnoticed at the time of the test. This intrusion is believed to have produced damage within the battery that eventually led to a vehicle fire three weeks after the test was conducted. See Figure 2.03.

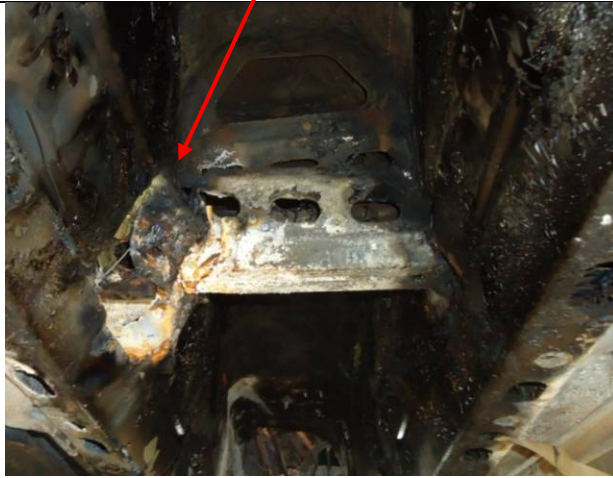
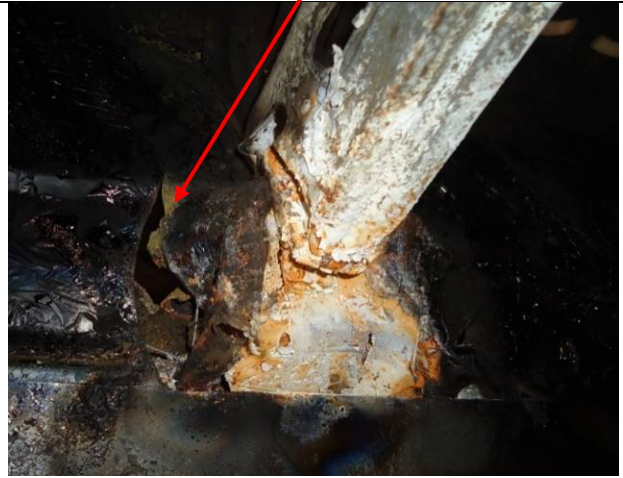
Figure 3.02

stiffener located under the driver's seat penetrated the tunnel section of the battery compartment (see Figure 3.02), damaged the lithium-ion battery, and ruptured the battery's liquid cooling system. Review of the crash test photographs and video confirmed that battery coolant leaked from the battery compartment. See Figure 3.03. The results of the forensic inspections at VRTC are included in the MGA Incident report.

Opening between the battery and occupant compartments

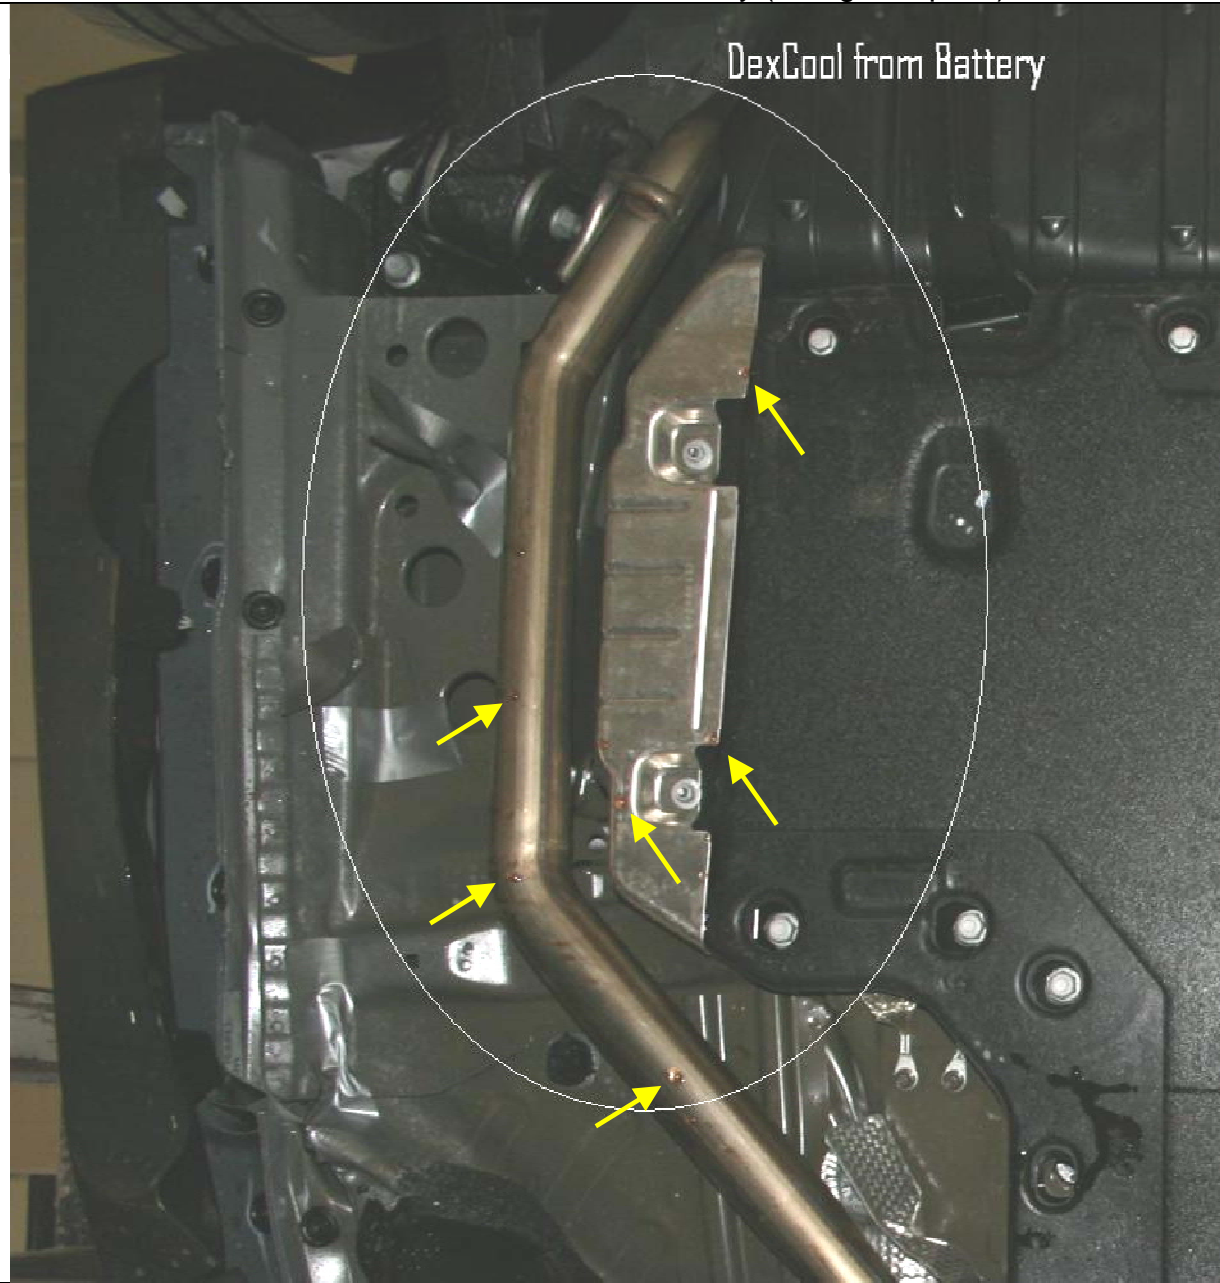
Figure 3.03

Leaked DexCool Coolant from Chevrolet Volt Battery (orange droplets)

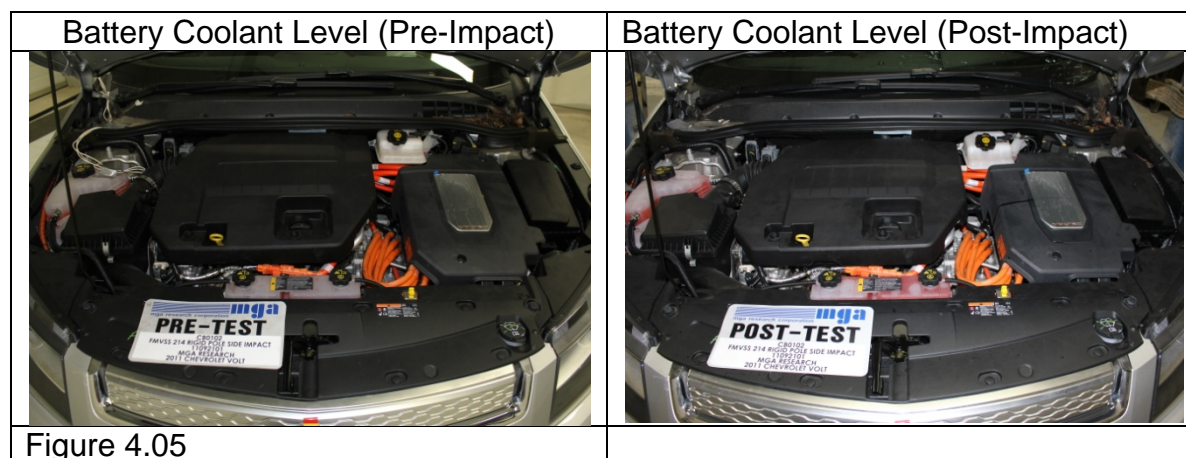
No significant battery deformation or intrusion was observed for the September 21, 2011 crash test. There were no signs of coolant leakage during the crash test or the subsequent rollover test as evidenced by the coolant reservoir level post-test. See Figure 4.05. No thermal or electrical activity was observed in the vehicle or the battery immediately after impact or during the three week monitoring period following the test.

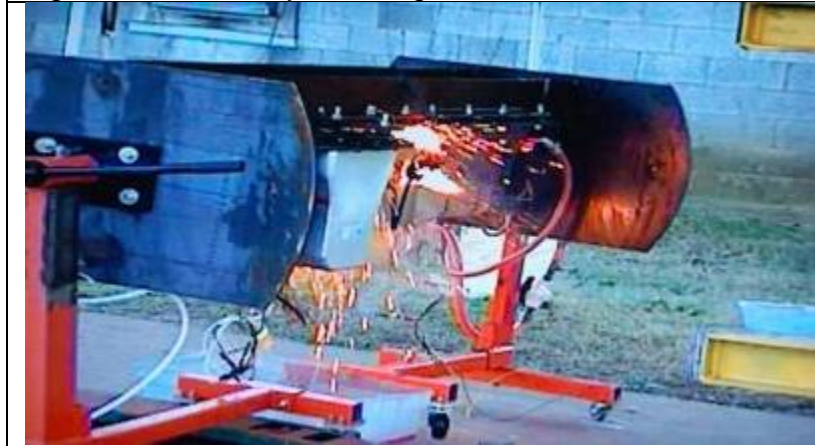
Figure 5.04 Battery 3 Arcing Event

During Test 3, while the battery was inverted, an event occurred resulting in smoke, and finally an arcing event that jetted sparks and flames from the battery housing for about a second. See Figure 5.04.

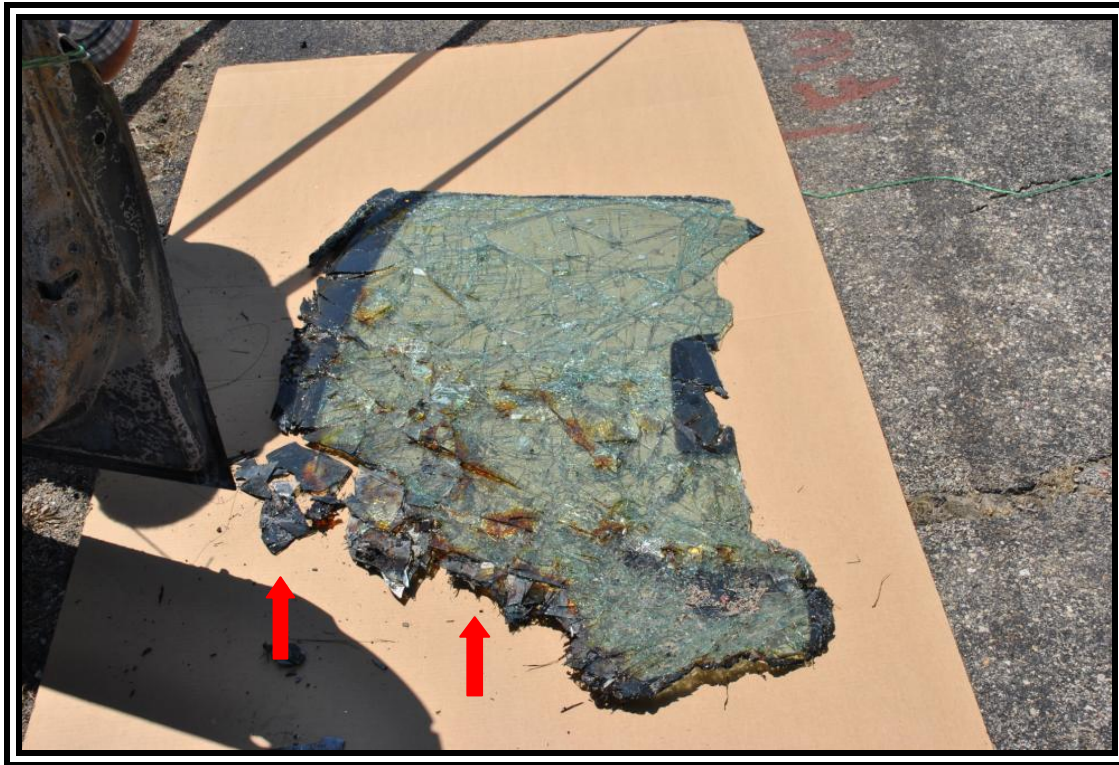
2011 Chevrolet Volt, recovered windshield glass exhibiting thermal damage at contact with burned vehicle

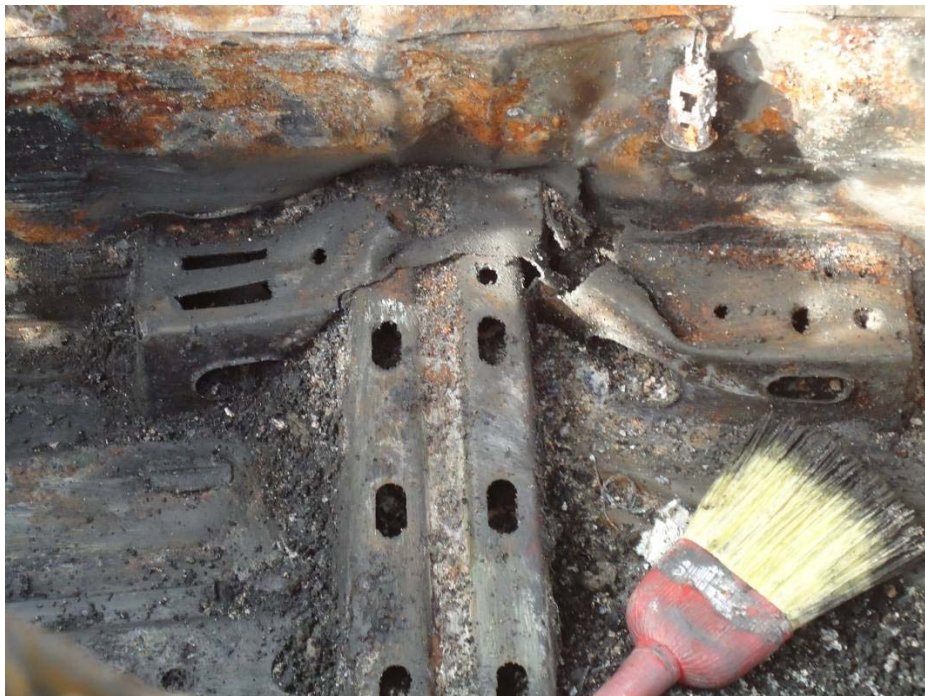
Figure 3.1-2. Crash Test Damage to the Outside of the Battery Compartment (Tunnel Section)

The initial inspection revealed that the transverse stiffener located under the driver's seat had penetrated the tunnel section of the battery compartment and damaged the lithium battery. A photograph of the damage to the outside of the tunnel is shown in Figure 3.1-2.

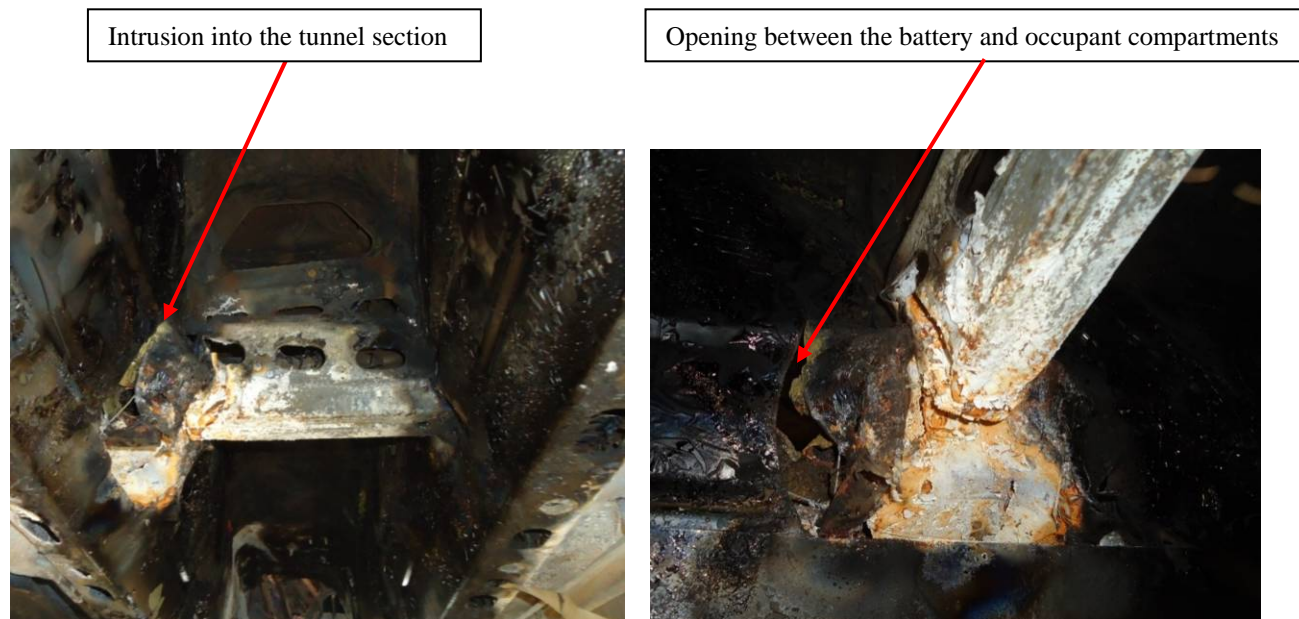
Figure 3.1-3. Crash Test Damage to the Inside of the Battery Compartment (Tunnel Section)

An inspection inside of the tunnel revealed that the transverse stiffener and tunnel structure had been pushed about 3 inches into the battery compartment and penetrated the side of the battery cover. A photograph of the inside of the tunnel section of the battery compartment showing the intrusion is provided as Figure 3.1-3 (left photograph).

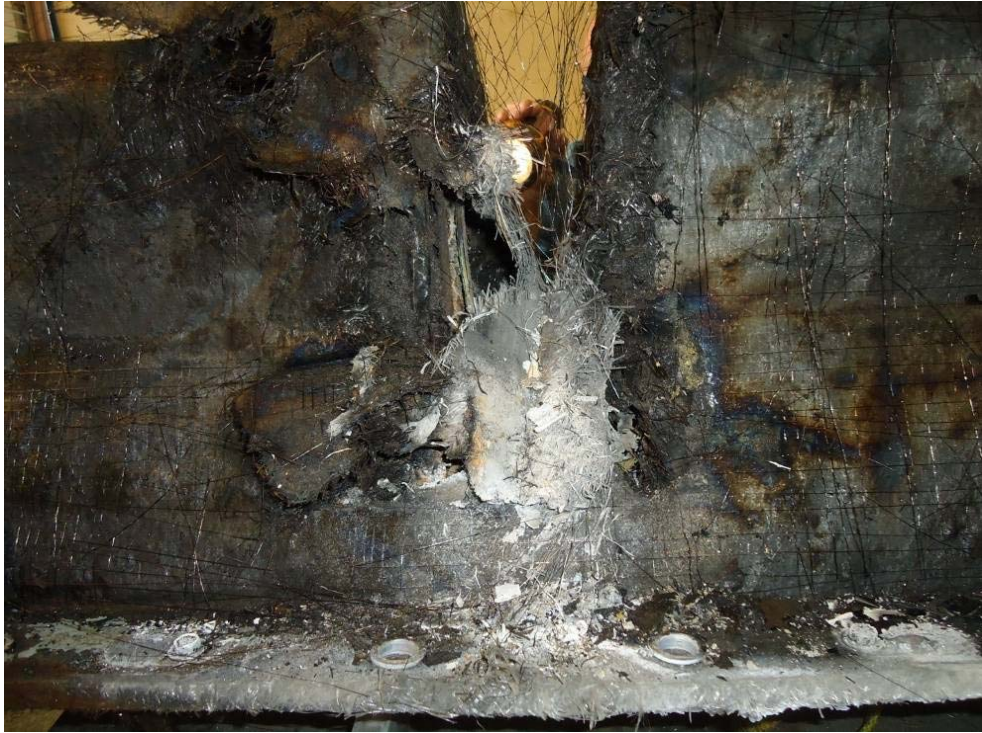
Figure 3.1-4. Battery Cover Damage at the Impact Location

The outer cover of the battery and the battery itself were damaged at this location and exhibited signs of higher thermal exposures. The fiberglass structure had been breached at this location and all of the resin within the structure had been consumed by the fire. This is evident by the white colored glass fibers in the damaged area as shown in the photograph provided as Figure 3.1-4. The battery cells in this area were also physically damaged during the crash test and will be discussed in the following section of this report.

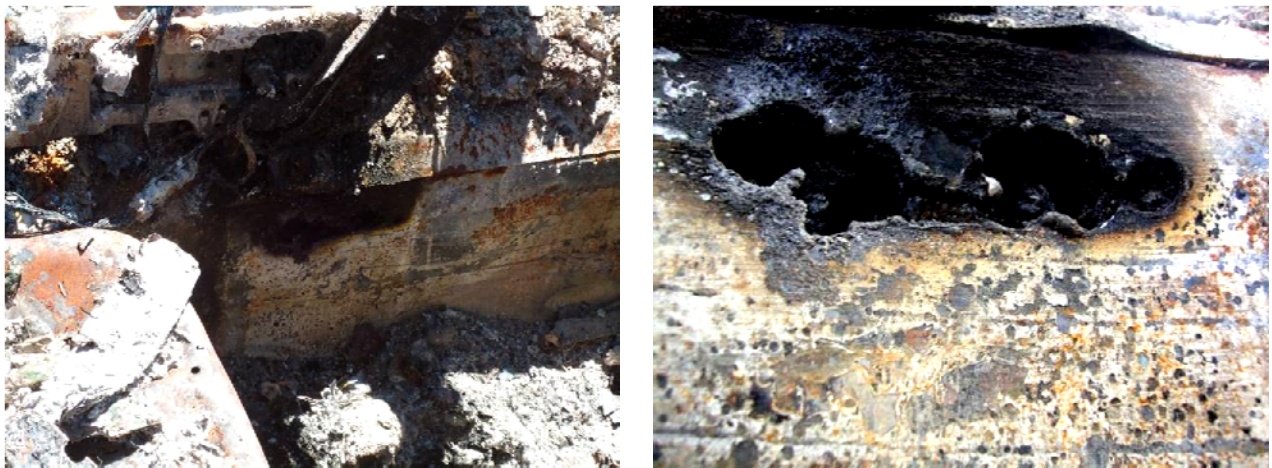
Figure 3.1-5. Holes in the Tunnel Section of the Battery Compartment Produced by Arcing

There were at least seven areas between the occupant and battery compartments that were breached during the event. It was concluded that these holes were produced as a result of the battery arcing (shorting) to the car chassis. It was determined that some of the battery connections had melted off during the fire energizing part of the battery support structure. A photograph of one of these arcing holes is provided in Figure 3.1-5. Additional information of this arcing is provided in the following section of this report.

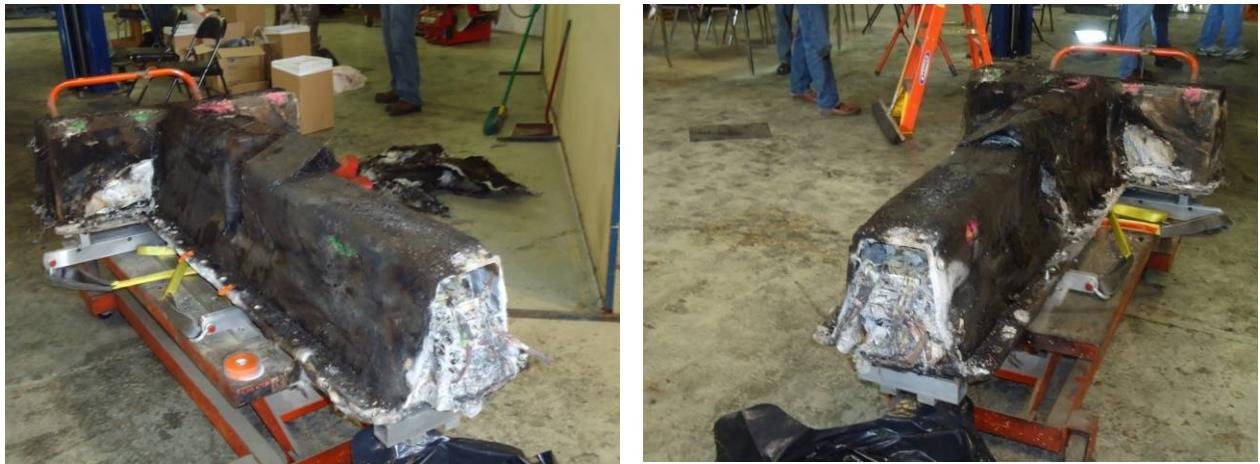
Figure 3.2-1. Battery Cover Photographs

3. All of the visible battery electronic components (wires, circuit boards, etc) were completely consumed by the fire.
4. There were at least seven holes in the battery cover created by arcing between the battery and the car chassis. These areas are indicated by the color spots (green and pink) on the photograph in Figure 3.2-1.

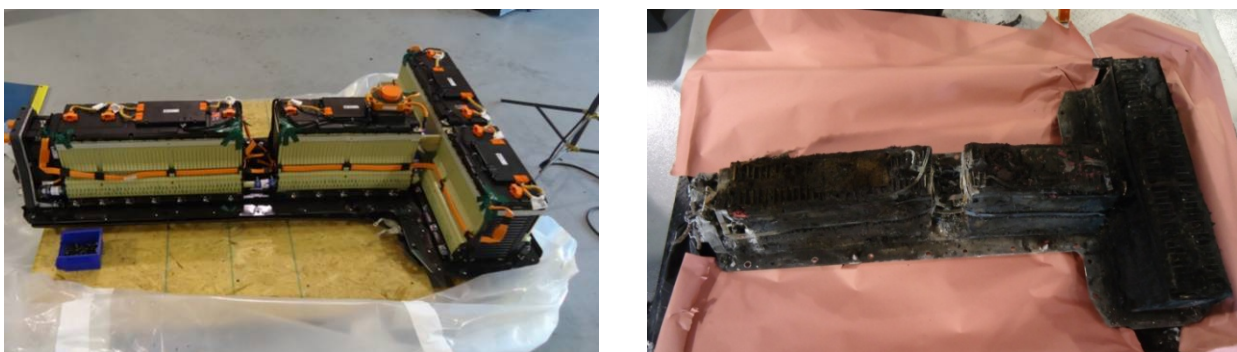
Figure 3.3-5. Overall Battery Condition Photograph

A photograph of the battery after the cover had been removed is shown in Figure 3.3-5 (right photograph). As a reference, an unburned battery is shown in the photograph on the left (Figure 3.3-5). As shown in this figure, the battery was still fairly intact after the fire.

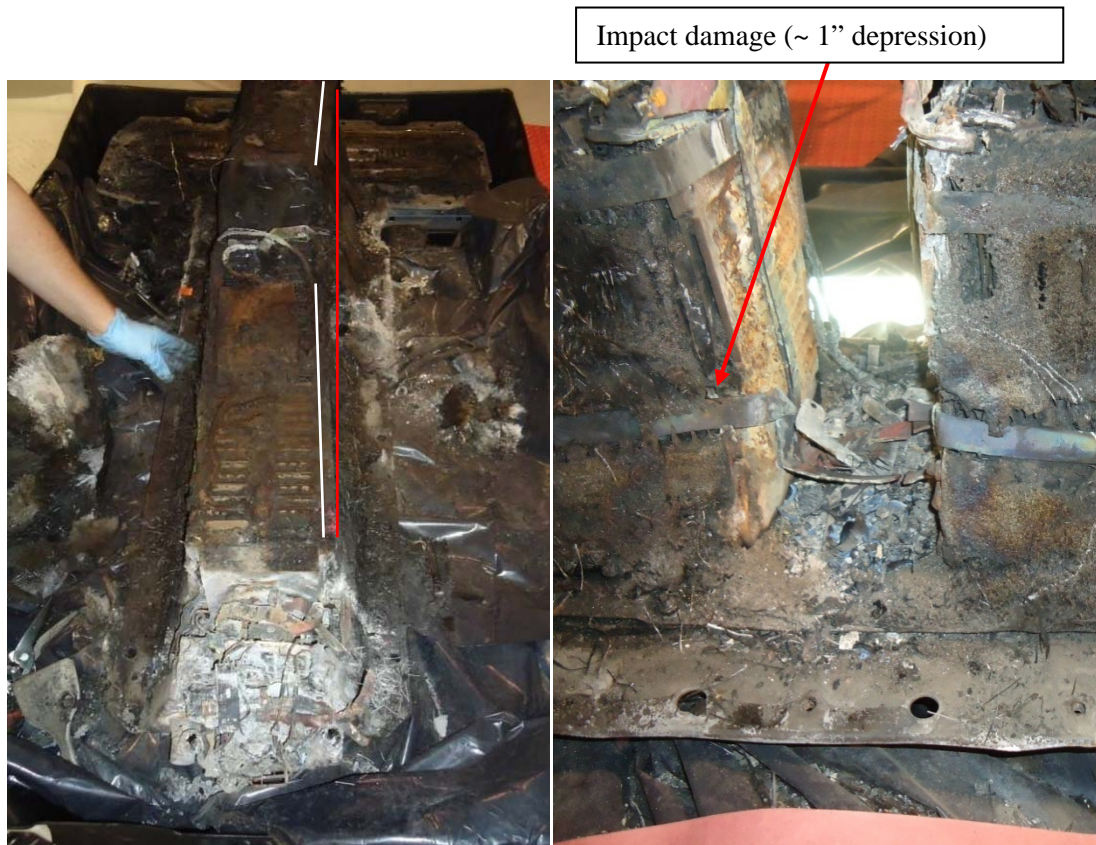
Figure 3.3-6. Physical Battery Damage

As a general observation, all of the visible combustible electronic components (wires, wire insulation, circuit boards, plastic housings, etc) were completely consumed by the fire. There was a limited amount of unburned plastic material located around the cooling line on the sides of the battery. This unburned material was melted and was covered with a layer of char which may have prevented the material from being completely consumed by the fire.

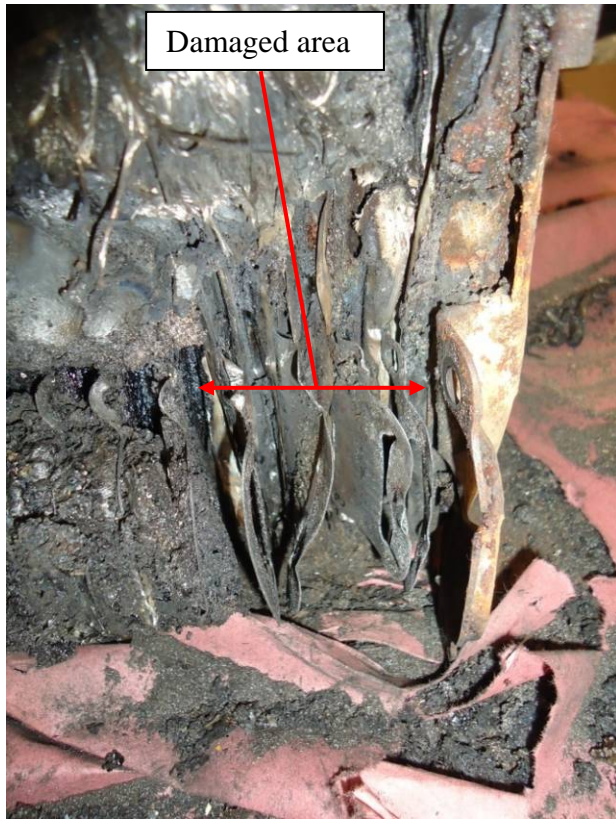
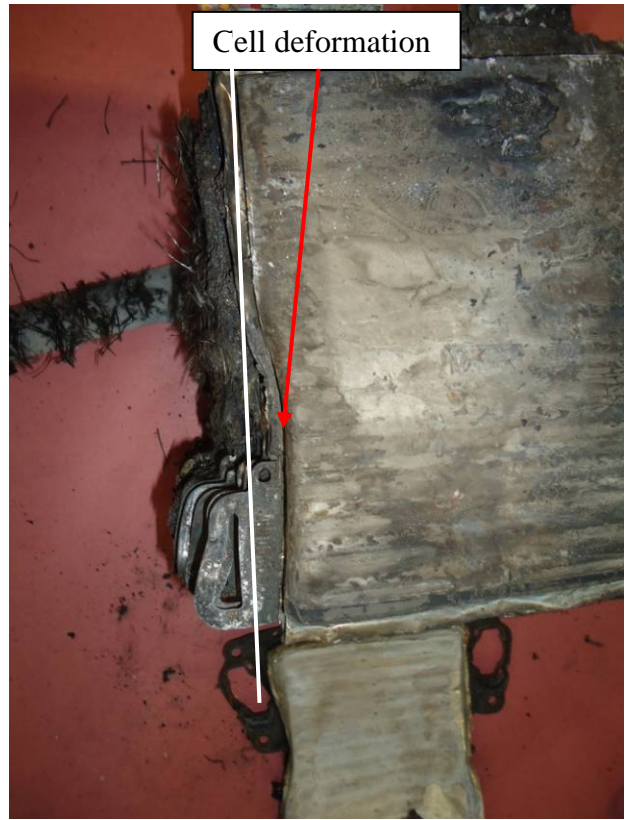
Figure 3.3-9. Side and Front View of Cells 198-204

An inspection of the first few cells (cells 198–204, cooling fins 100–102) revealed that the anode and cathode metallic sheets and the separators had been damaged during the crash test. A side view and front view of this area is provided in Figure 3.3-9. Upon removal of the cells, a distinctive crease was observed in the anode and cathode sheets of these cells and is shown in the photograph in Figure 3.3-10. The cooling fins also showed a similar amount/type of damage.

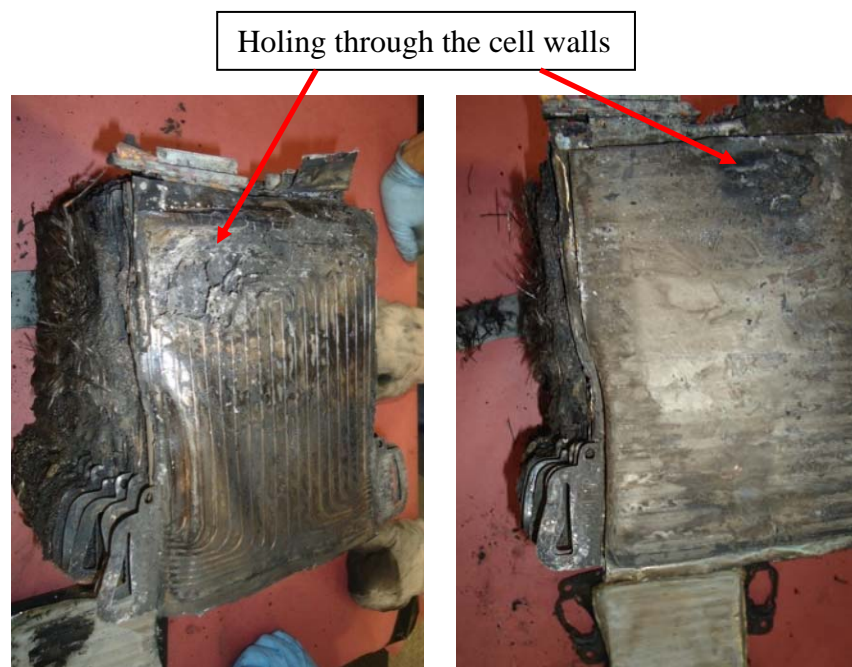
Figure 3.3-11. Remains of Cells 198–204

Even with the advances made by GM/LG on cell construction and chemistries, there is a good possibility that the physical damage to cells 198–204 (i.e., damage to the separator(s) within the pouch cells) that occurred during the crash test produced an internal short within the cell(s) that resulted in the release of flammable vapors (electrolyte) that were eventually ignited and initiated the fire within the Chevrolet Volt.

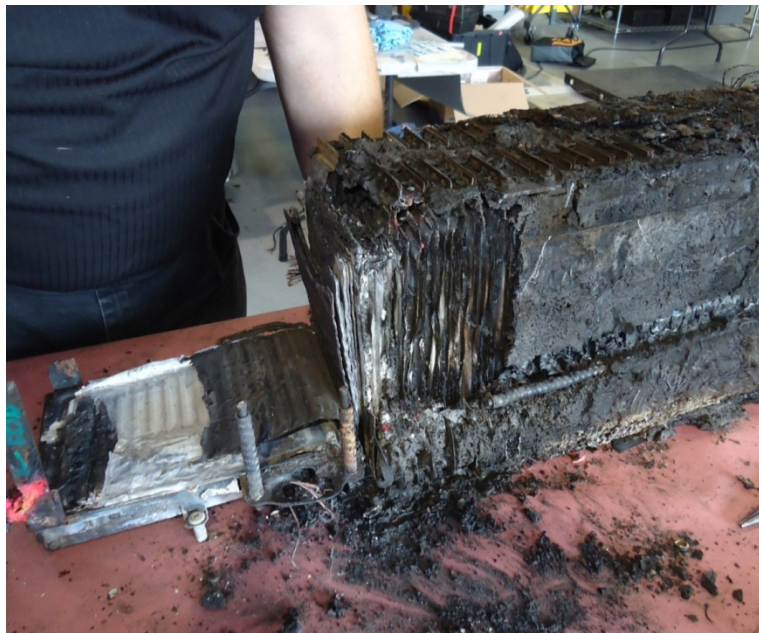
Figure 3.3-12. Side View of Cells 188–197

The initial inspection of battery pack indicated that the last few cells in Module 2 (cells 188–197, cooling fins 94–99) could have been damaged during the crash test. A side view of this area is provided in Figure 3.3-12. Upon removal of the cells, it was determined that the damage to the cell components (anode, cathode and separator) was superficial and did not appear to have caused an internal short within the cells; although the cells did undergo a thermal reaction during the event.

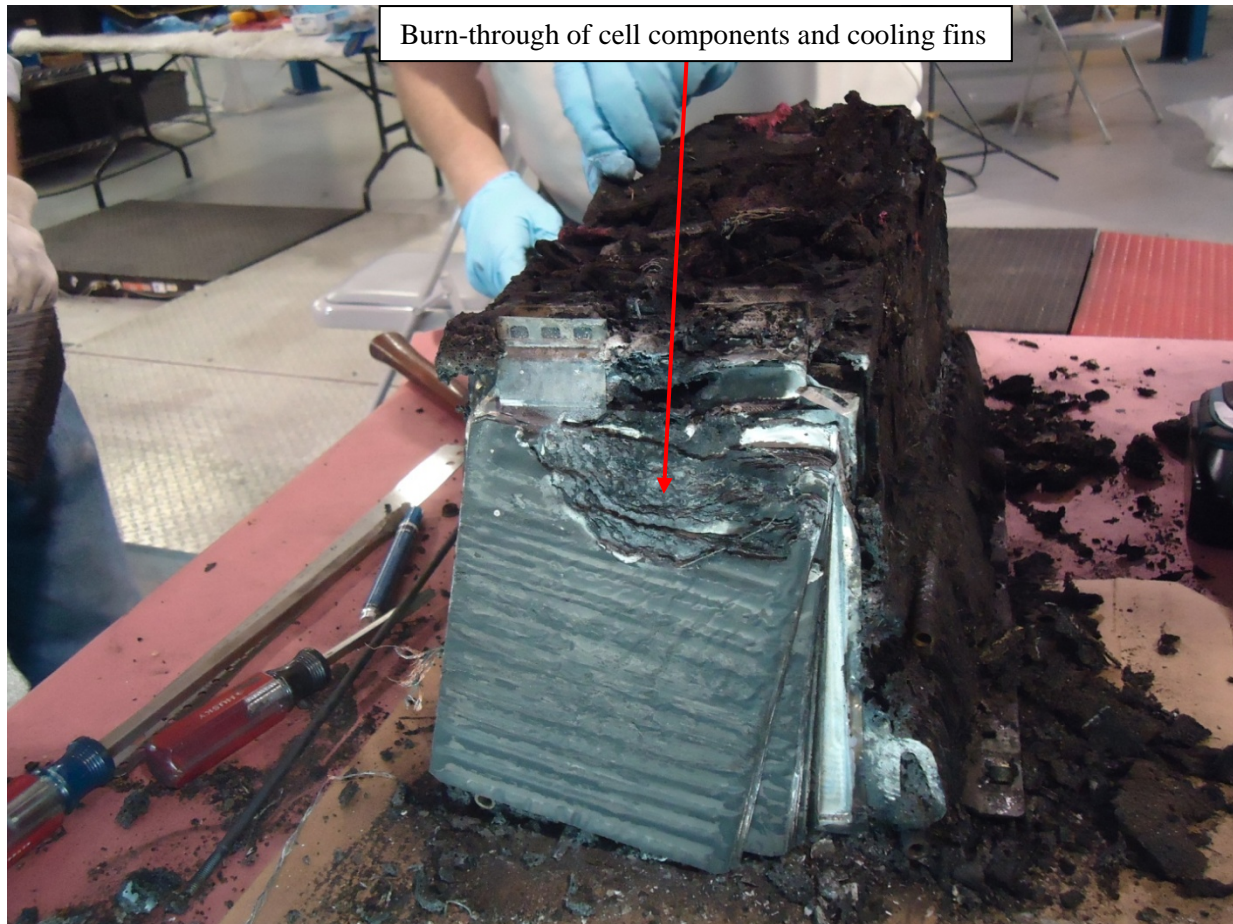
Figure 3.3-13. Remains of Cells 188–197 (“V” pattern)

The cells at the front end of Module 1 and both ends of Module 3 also had “V” shaped burn patterns similar to the one shown in Figure 3.3-13. Consistent with the findings of the previous discussion, these patterns were likely caused by external heating from a fire burning at these locations. Although these reactions were most likely caused by an external short, these are still considered to be “cell level” reactions since the current collector sheets were burned completely through at these locations.

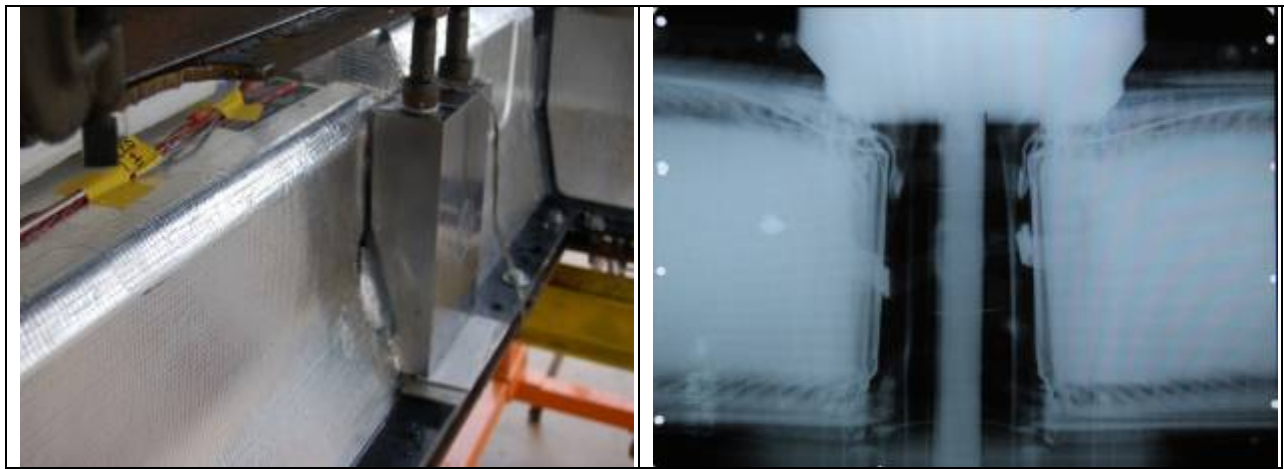
Figure 7.1 - Test 1 Battery Damage and X-Ray

There were only two minor differences between the two tests. During Test 1, the impactor block was not intentionally grounded to the mounting frame as was the case for Test 2. In addition, the degree of physical damage was slightly increased for Test 2 by adjusting the depth of impact and increasing the test impact velocity. A photograph and an X-ray of the damage for the two tests are provided in Figures 7.1 and 7.2.

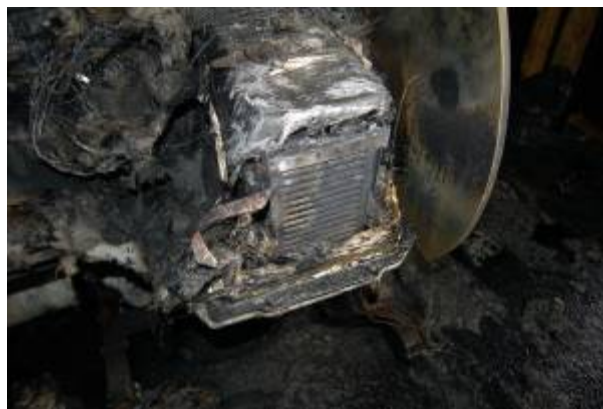
Figure 7.7 – Photograph Showing Cover Damage on the Driver's Side end of Module 3

A single or multiple cell level event (i.e. rapid venting of electrolyte) is the most likely scenario. This would also explain the opening in the case at the driver's side end - Module 3 of Battery from Test 2. A photograph of the opening is provided in Figure 7.7.

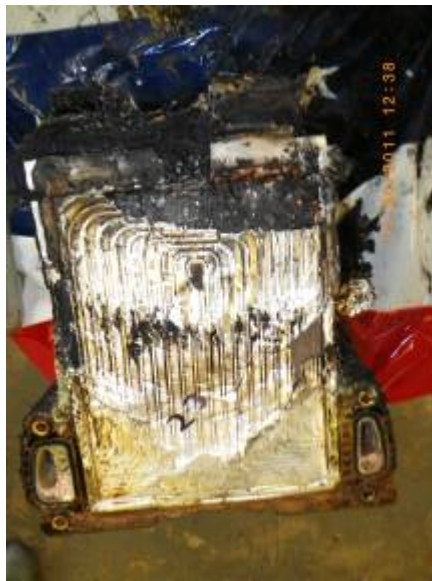
Figure 7.9 – Photograph Showing Cell Level Damage within Module 3

As stated previously, it is also believed that this cell venting blew apart the battery cover at the end of Module 3 during the fire and may have blown open the doors to the shed when the fire department first arrived on scene.

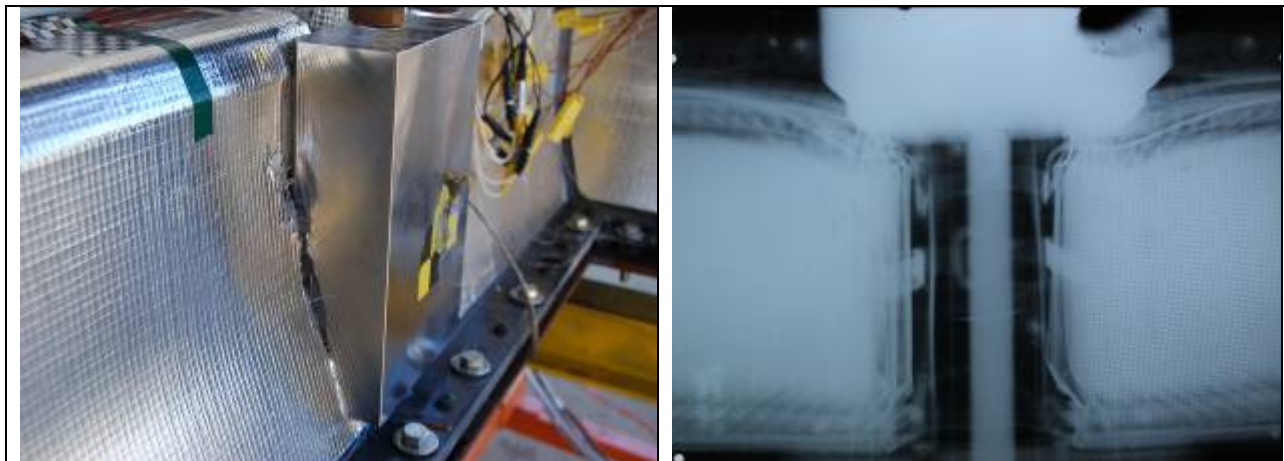
Figure 7.10 – Test 3 Battery Damage and X-Ray

The impact penetration was slightly increased for each test in an attempt to reproduce the damage to the battery produced during the crash test conducted in May at the MGA facility in Wisconsin. The amount of battery coolant (ethylene glycol/water mix 50/50) leaked into the pack was also greater than that leaked during the first two tests. A photograph and an X-ray of the damage for this test is provided in Figures 7.10.

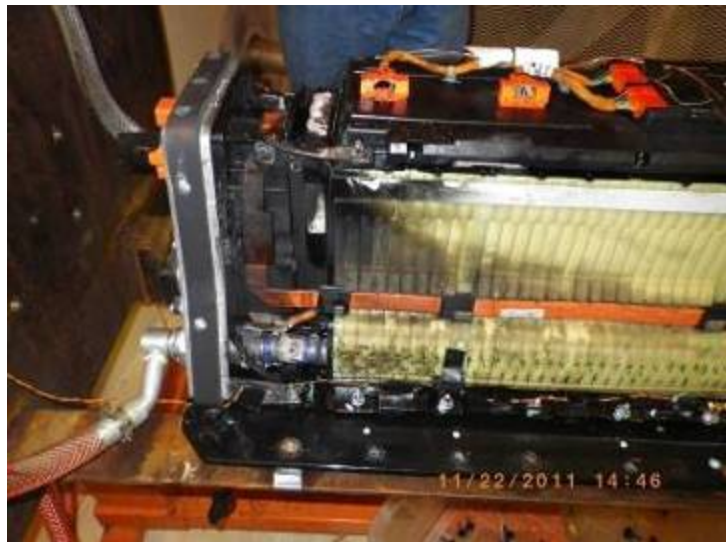
Figure 7.13 Arcing Damage to the Front of Module 1

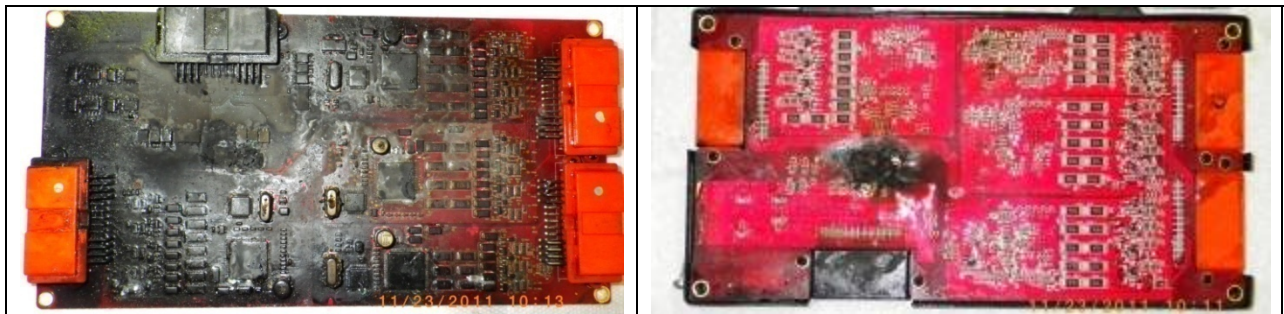
Figure 7.14 Arcing and Heating Damage to VTSM 1

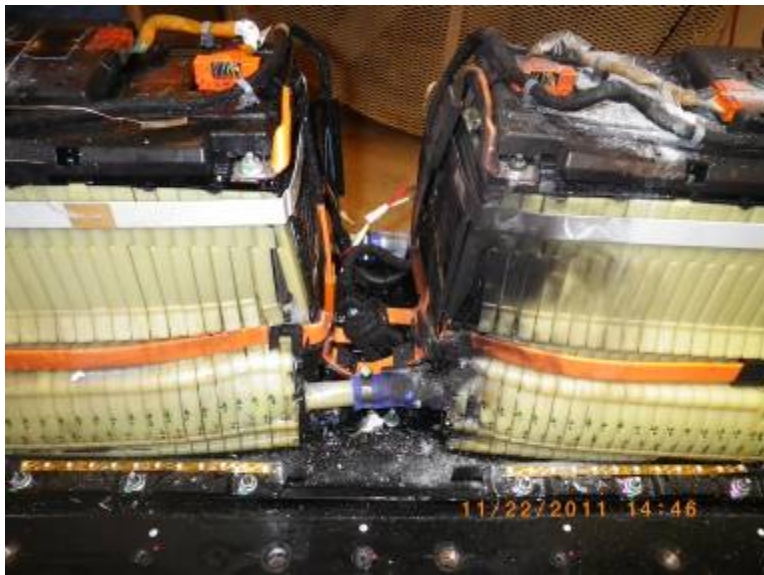
Figure 7.15 Arcing Damage to the Front of Module 2

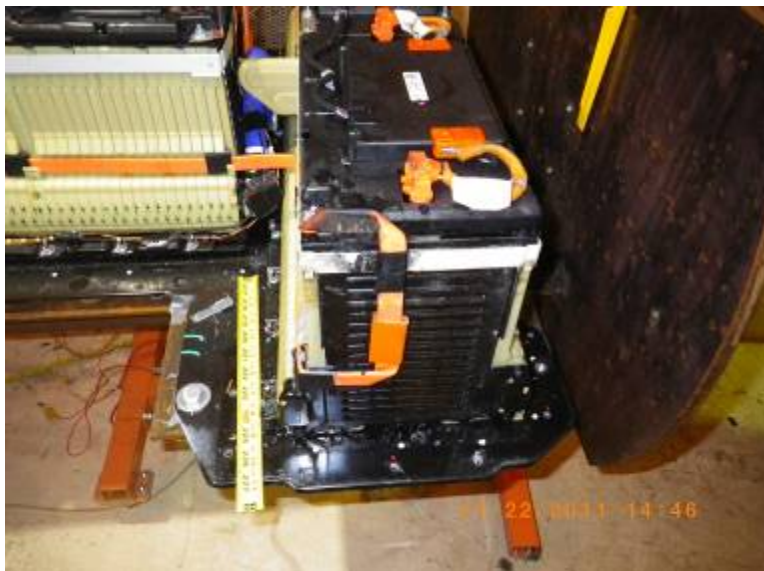
Figure 7.16 Arcing Damage at the Driver's Side End of Module 3

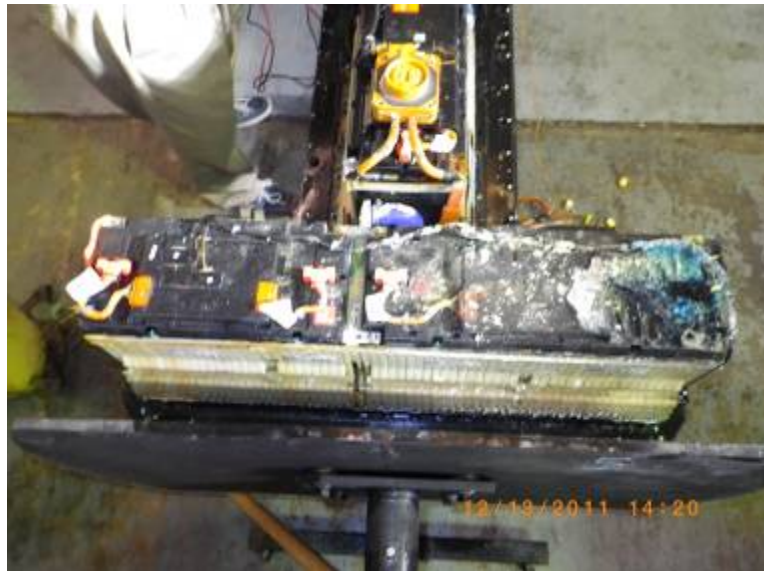
Figure 7.14 Fire Damage to Passenger Side End of Module 3

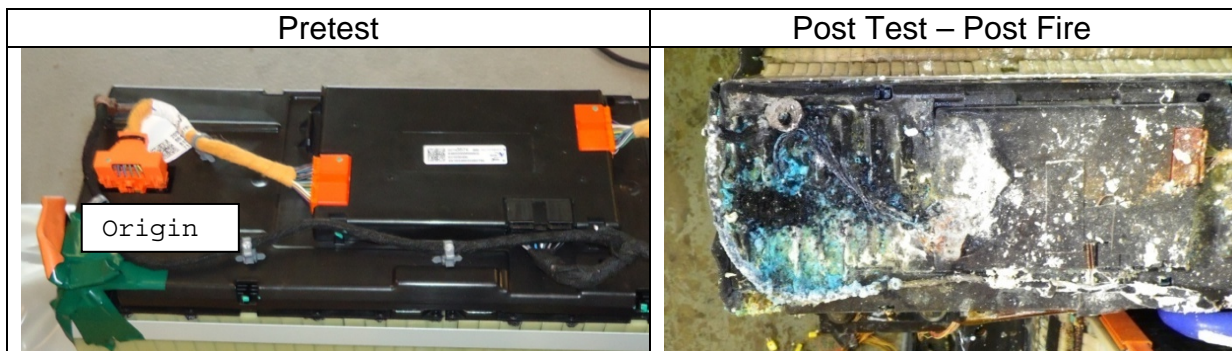
Figure 7.15 Fire Origin of Test 5 – Passenger Side End of Module 3

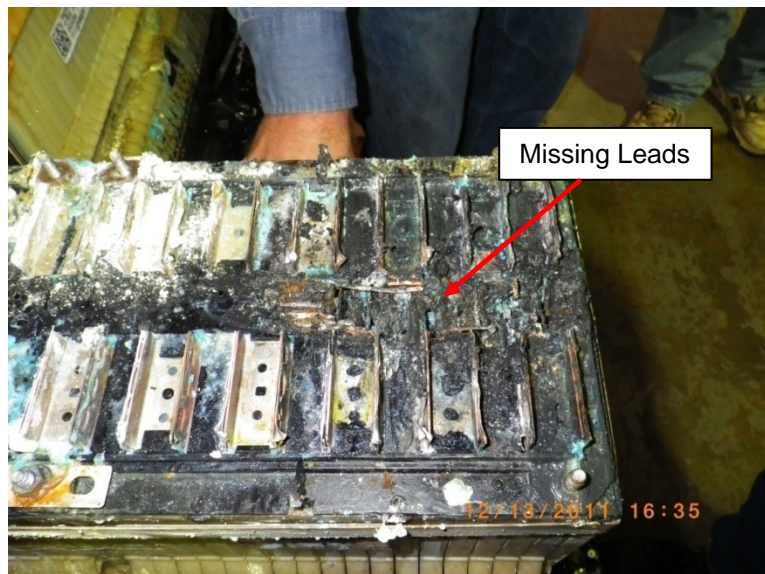
Figure 7.17 Fire Damage to the Bus Bar Leads
