U.S. Department
of Transportation
**National Highway
Traffic Safety
Administration**

DOT HS 811 573

January 2012

Chevrolet Volt Battery Incident Overview Report

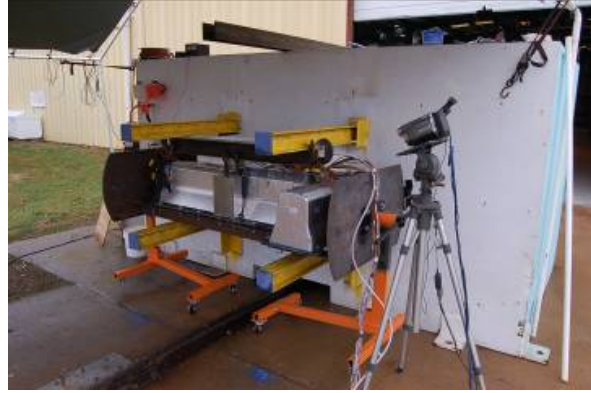
Figure 5.01 Battery Ready for Impact

Voltage monitoring, thermocouples and gas detection instrumentation were connected to the battery and verified for operation. See Figure 5.01.

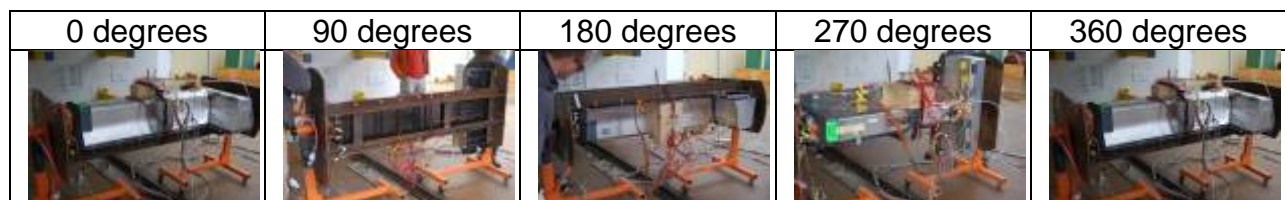
Figure 5.02 Battery Rollover Photographs

The battery remained on the support fixture for approximately one hour while it was being x-rayed. After completion of x-rays the battery/cradle was removed from the support fixture and an FMVSS 305 type rollover was initiated. The battery was manually rolled over, taking approximately one minute to rotate each 90° increment, and held for five minutes at the 90°, 180° and 270° positions. See Figure 5.02

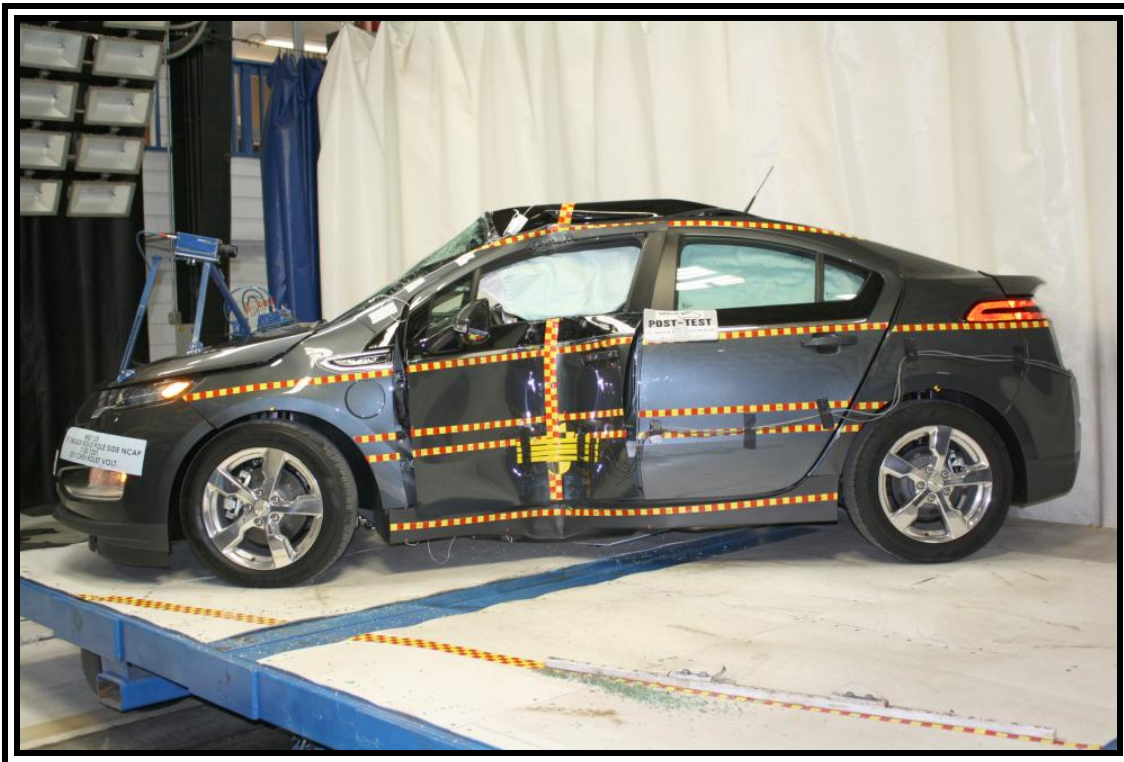
2011 Chevrolet Volt, post-impact, view from the driver's side

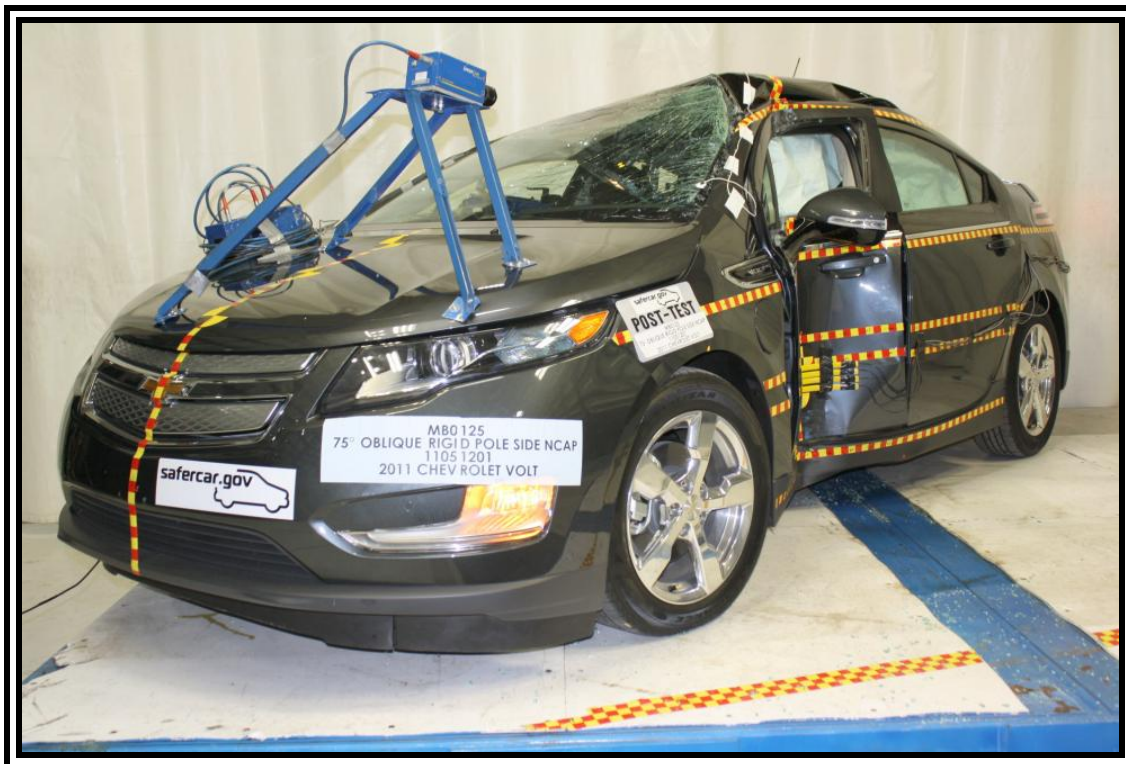
2011 Chevrolet Volt, post-impact, view from the driver's side front

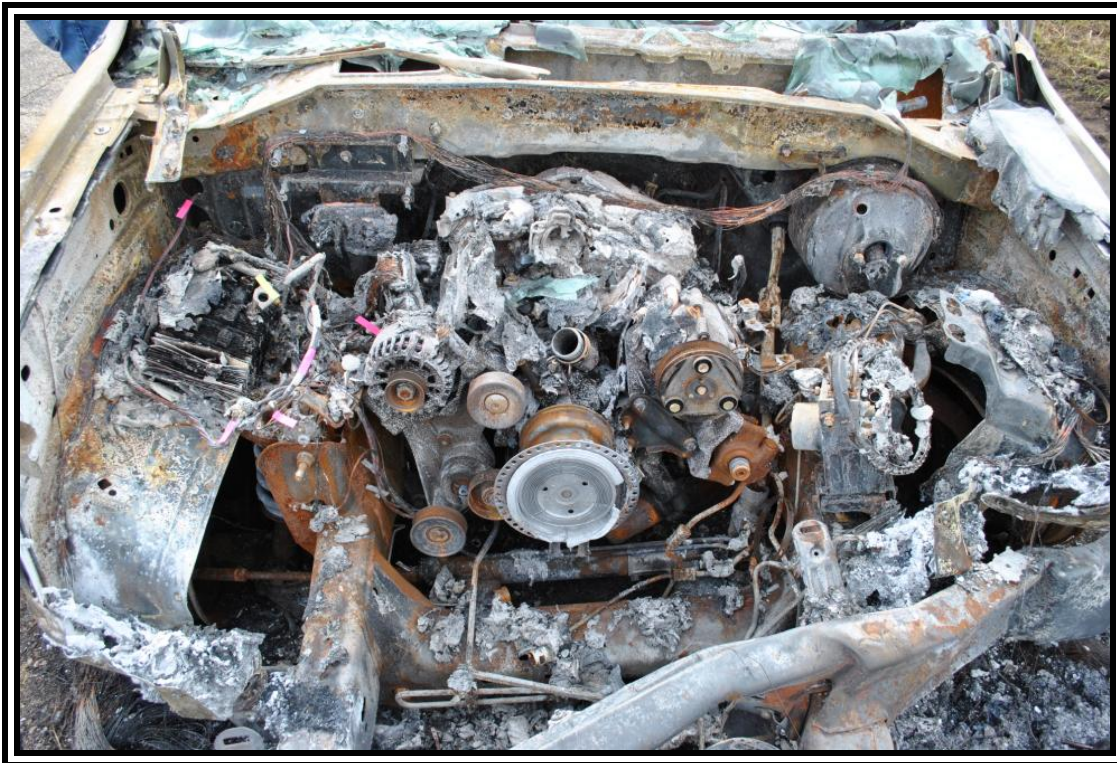
2006 Ford F150, +12vdc conductors

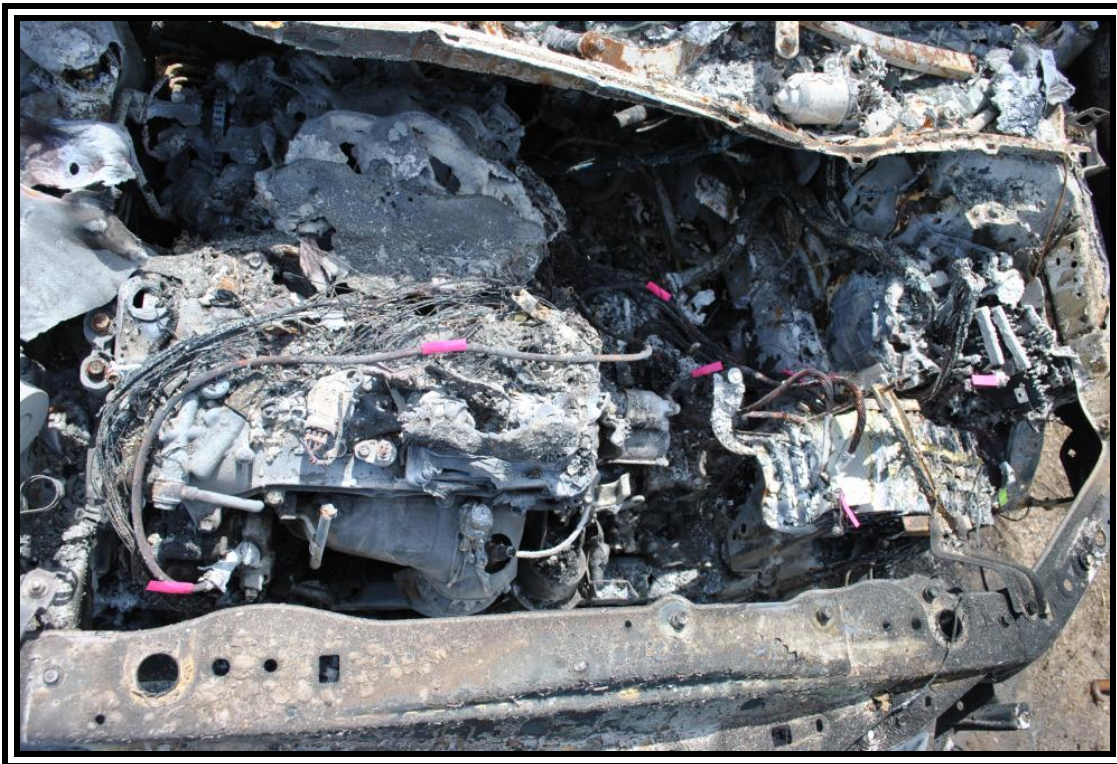
2011 Lexus RX350, +12vdc battery conductors

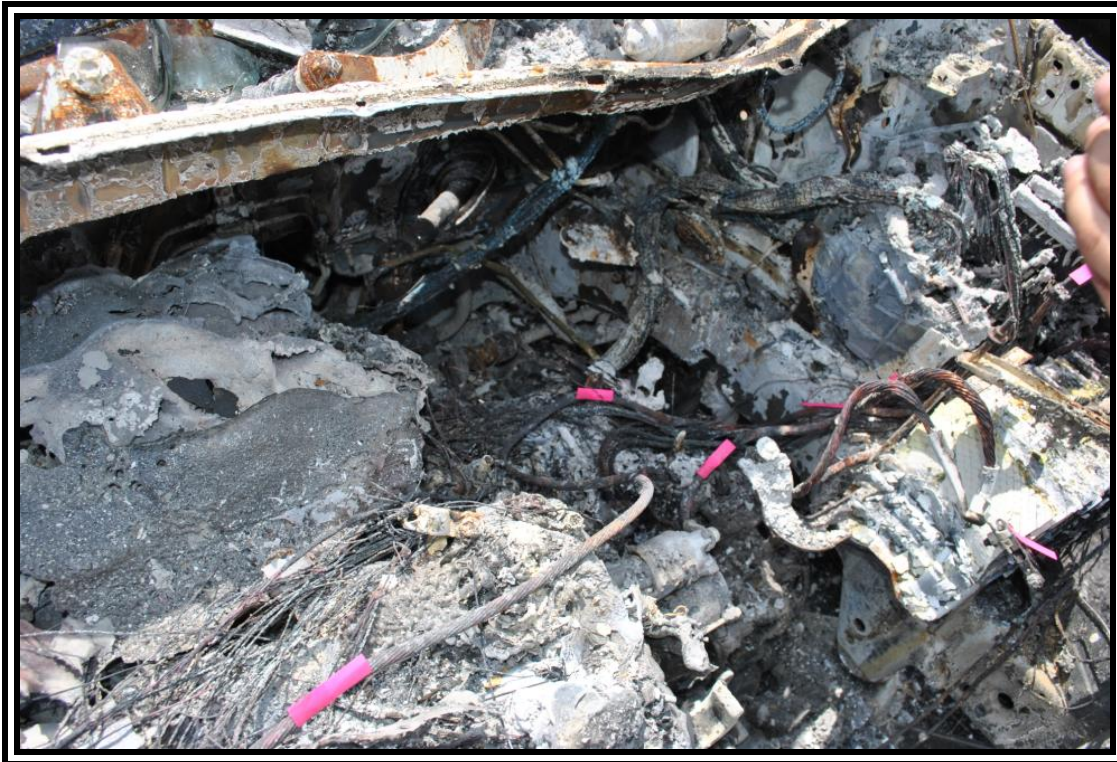
2011 Lexus RX350, +12vdc battery conductors

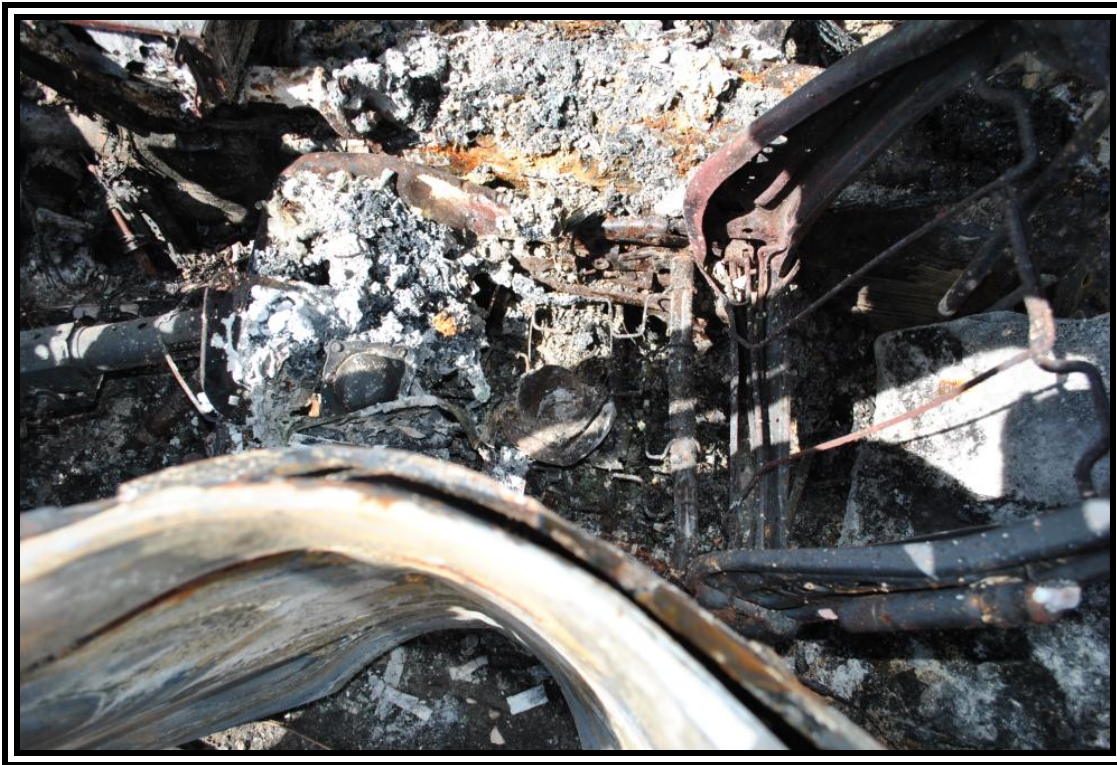
2011 Chevrolet Volt, view of the side impact and intrusion

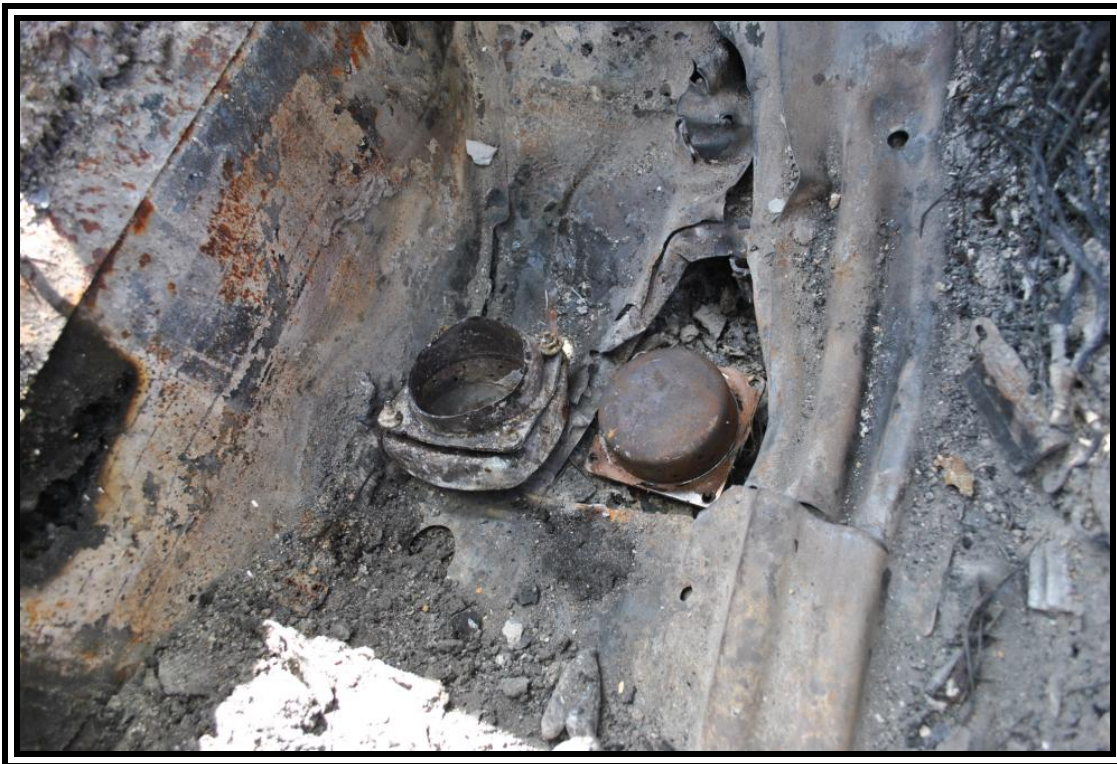
2011 Chevrolet Volt, passenger's side upper airbag module and exemplar module on passenger's side floor

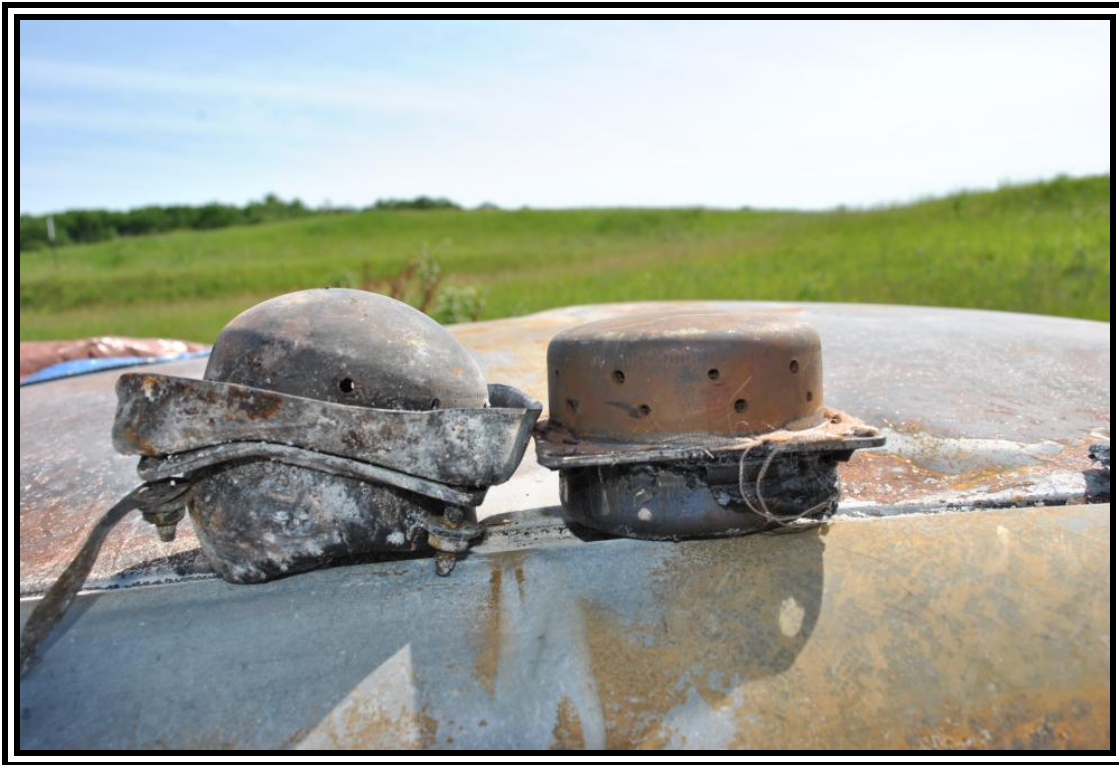
2011 Chevrolet Volt, comparison of the recovered airbag module to an exemplar

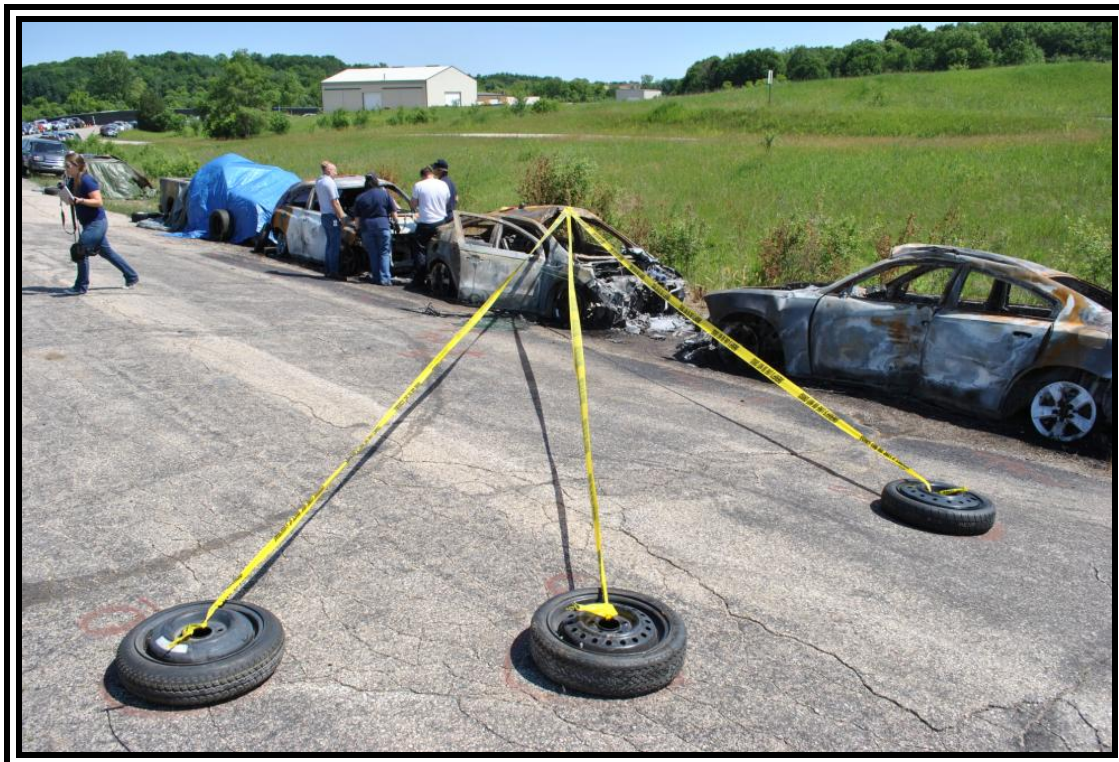
2011 Chevrolet Volt, trajectory illustration of interior rear view mirror components

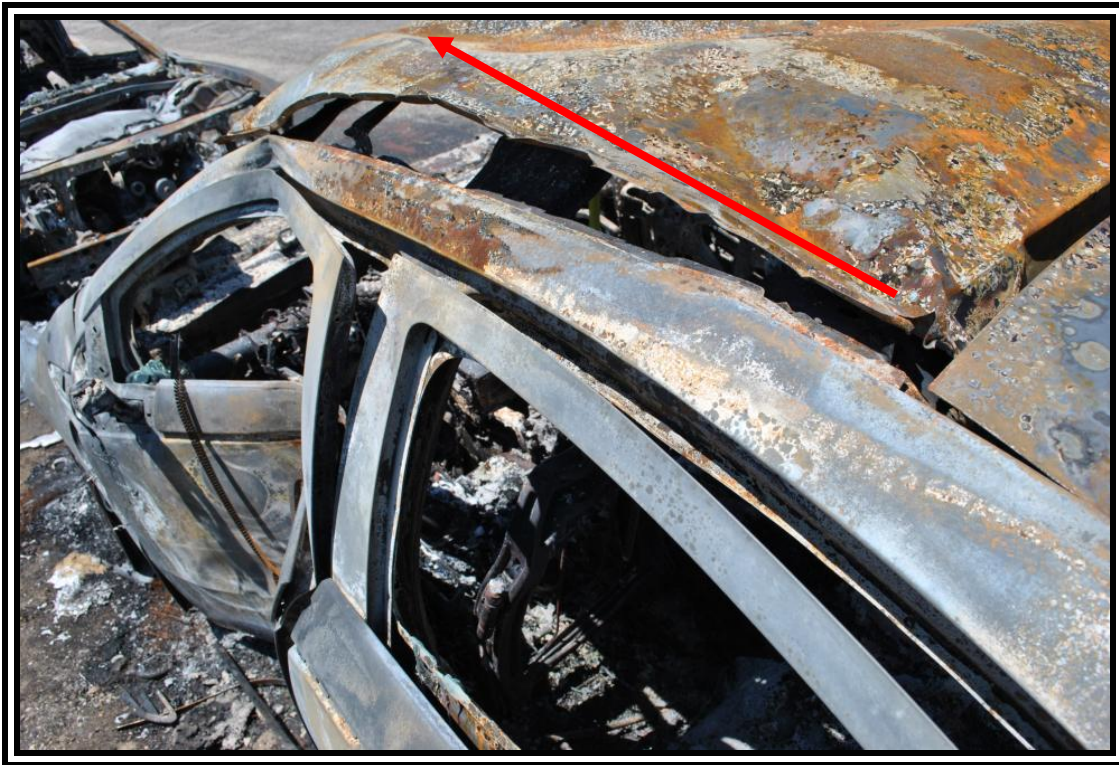
2011 Chevrolet Volt, dislodged roof sheet metal showing rear lift cylinder trajectory

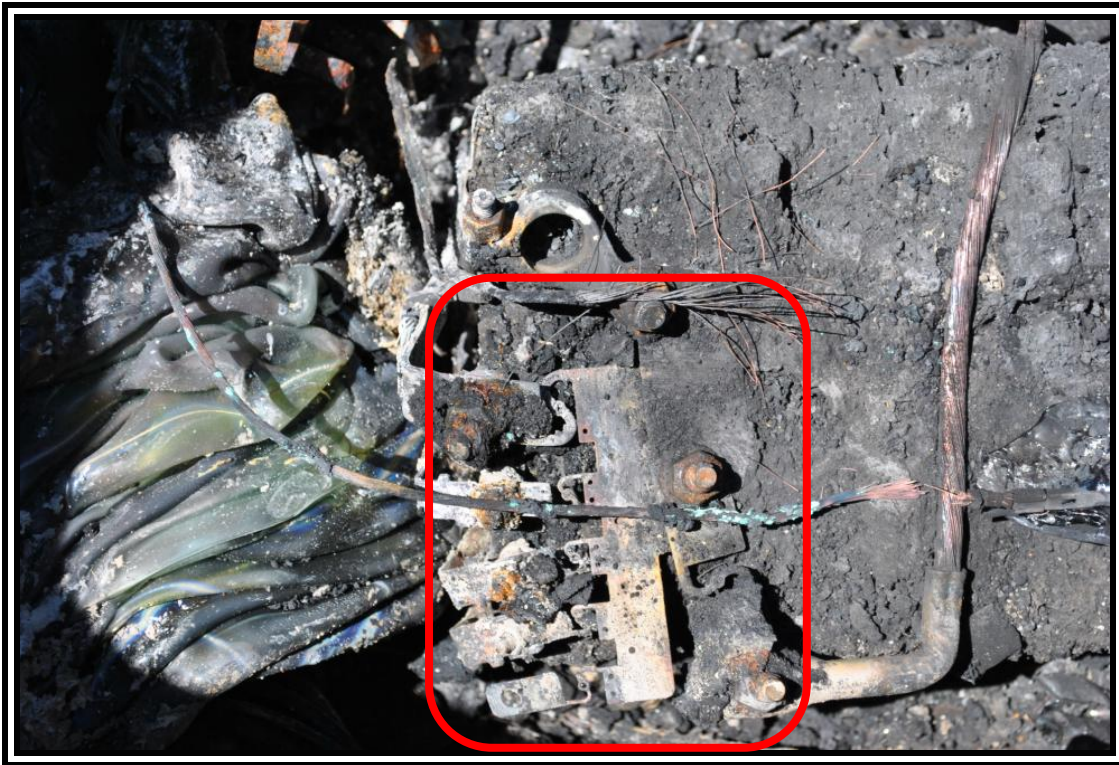
2011 Chevrolet Volt, intact +12vdc fuses at the battery

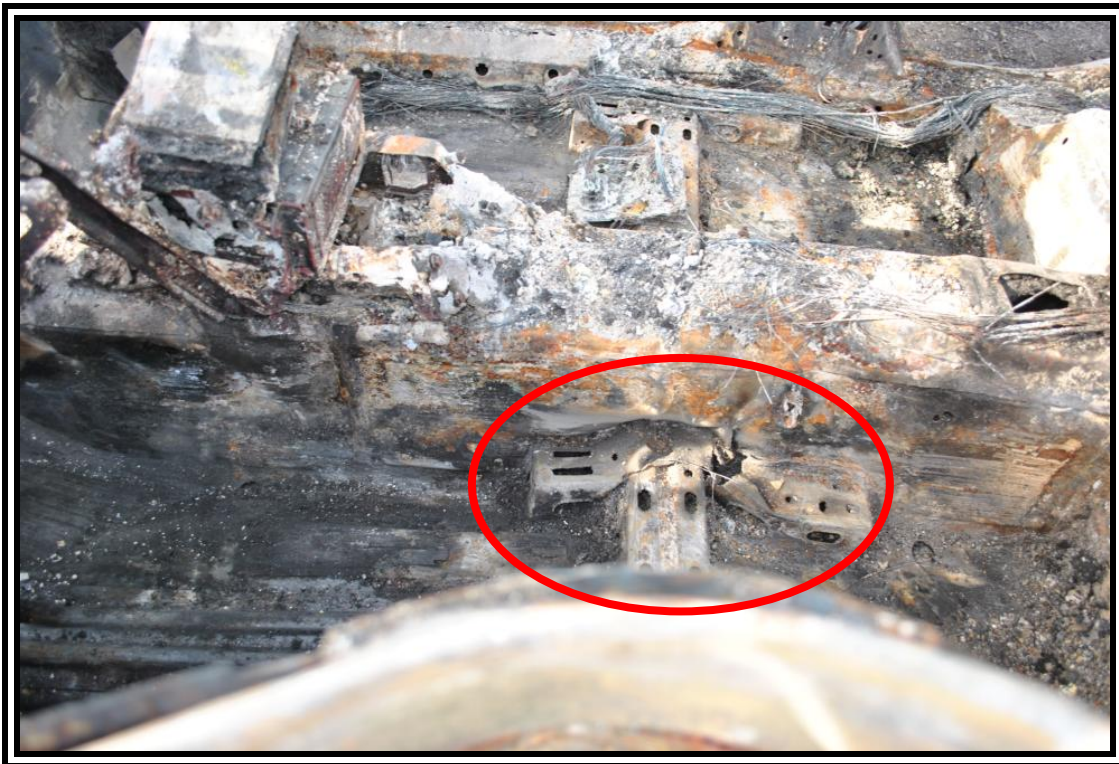
2011 Chevrolet Volt, driver's side interior showing impact intrusion into the center tunnel

An initial inspection of the crash damage to the Volt revealed that the transverse stiffener located under the driver's seat had penetrated the tunnel section of the battery compartment and damaged the lithium battery and the battery's liquid cooling system. For discussion purposes, the battery compartment includes the tunnel section located between the two front seats and the transverse section located under the back seat. It is more likely than not that this damage to the battery, battery compartment, and battery liquid cooling system caused the fire that destroyed the four vehicles at the MGA facility between June 3–6, 2011.

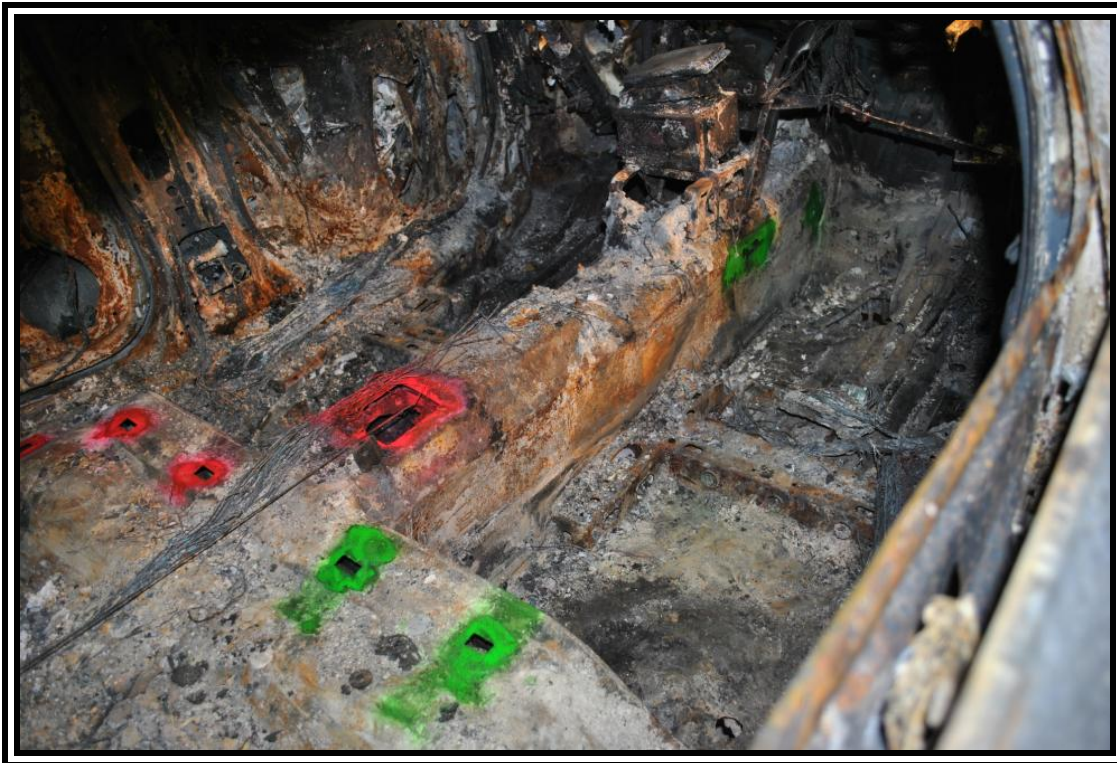
2011 Chevrolet Volt, GM paint marking of tunnel and battery

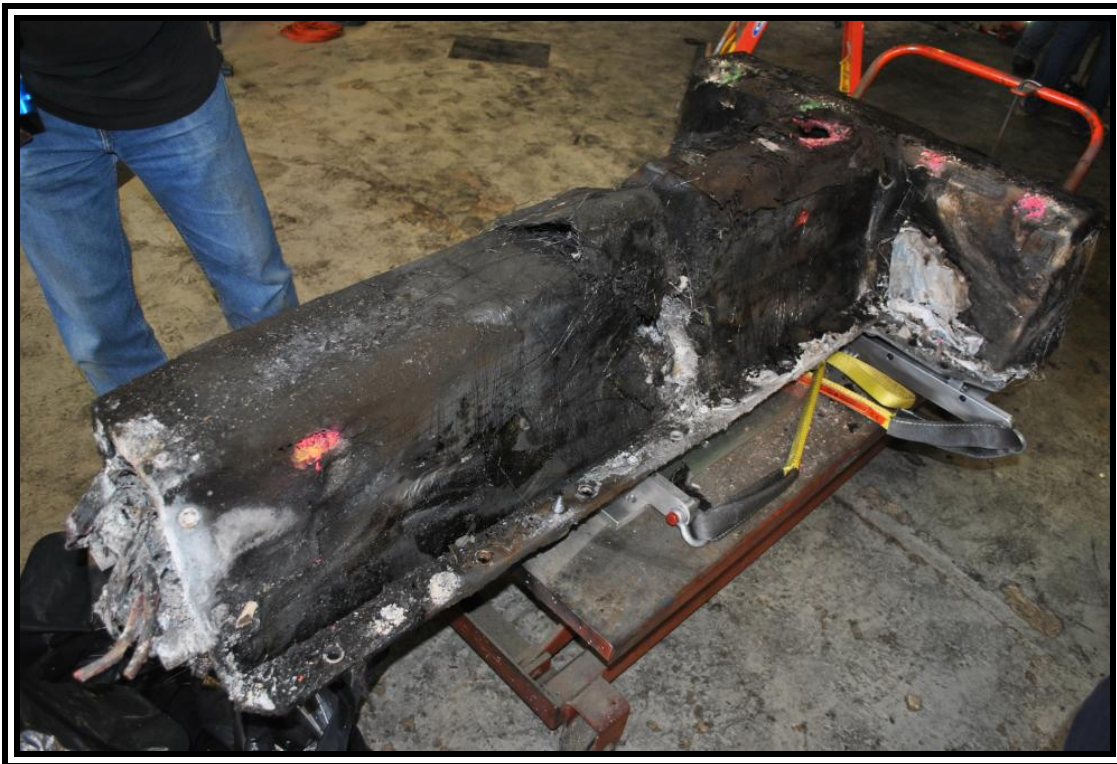
2011 Chevrolet Volt, driver's side of the high-energy battery pack

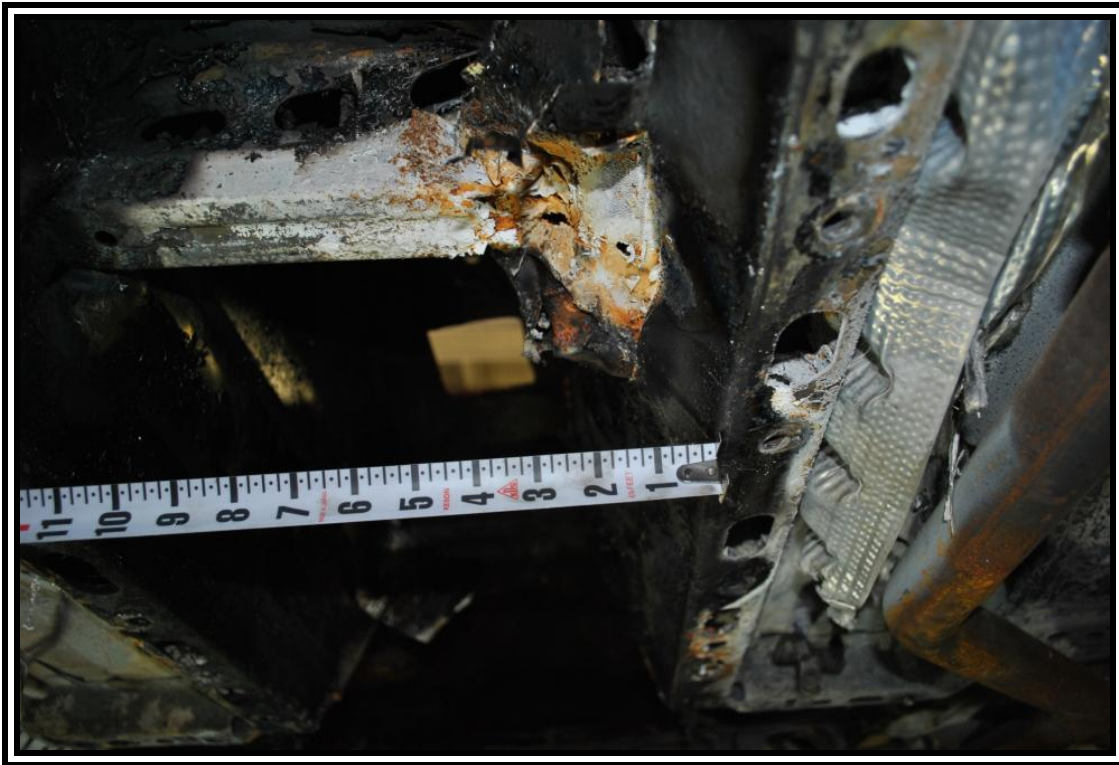
2011 Chevrolet Volt, measurement of intrusion into the battery pack tunnel

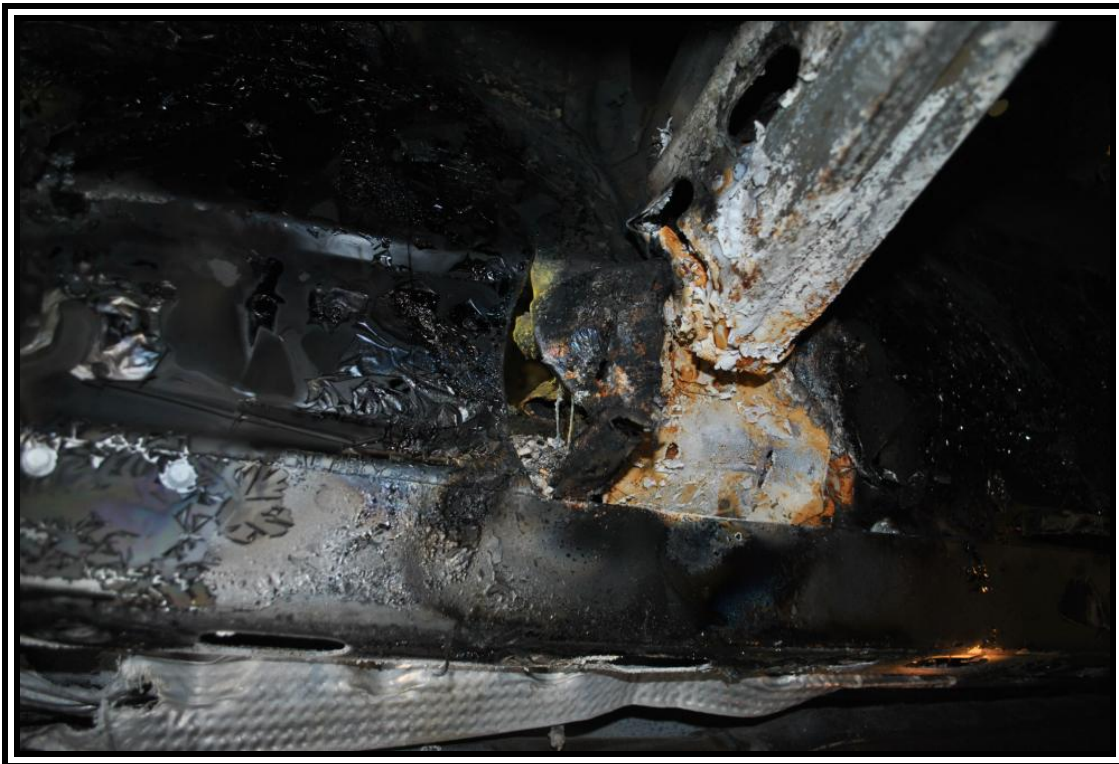
2011 Chevrolet Volt, view of the intrusion and opening from the tunnel to the vehicle interior

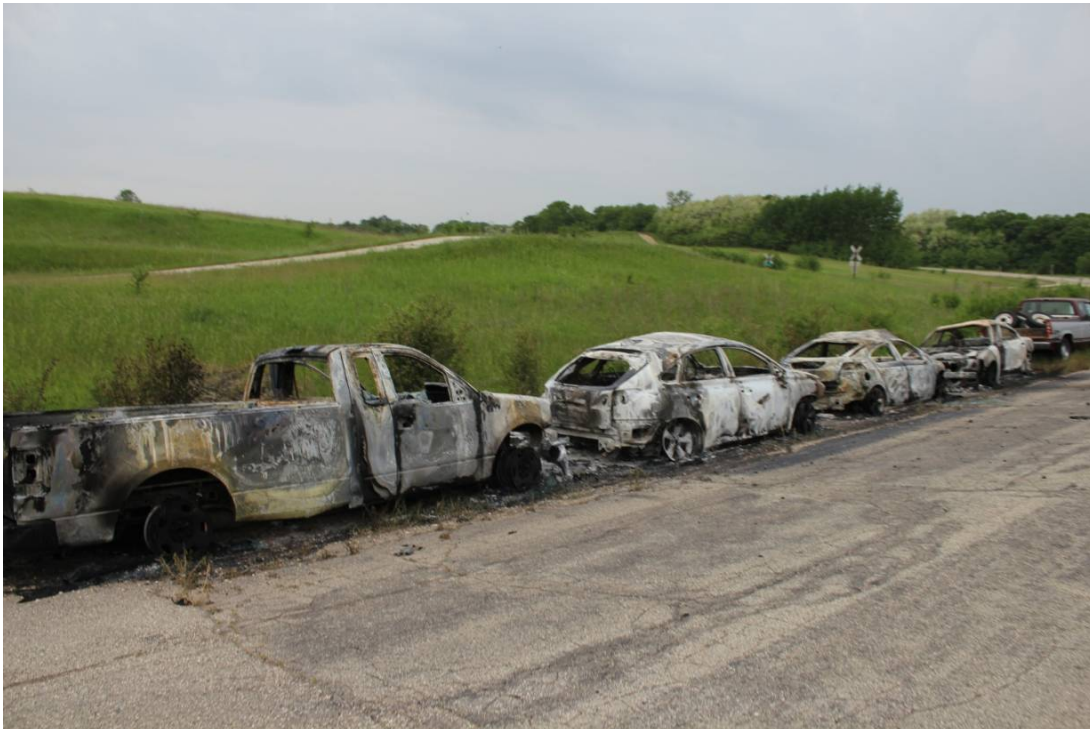
The vehicles were located at the northern portion of the testing facility. The Ford F150, Lexus, and Chevrolet Volt were parked front to back (all three vehicles were parked facing west). The Chevrolet Volt and Dodge Charger were parked front to front (the Charger was parked facing east). The Dodge Charger and the Chevrolet Z71 were parked back to back (the Z71 was parked facing west), all on the southwest side of the roadway. Vehicles were placed there with a forklift after having been crash tested (side impact test on the driver's side). The Ford F150, Lexus RX350, and Chevrolet Volt were crashed 3 weeks prior to the fire and the Ford F150 was tested in February 2011. Per the standard test procedures, the 12V batteries of all four vehicles were fully charged at the time that they were tested. The cars were spaced about 2–3 feet apart. A photograph of these vehicles is provided as Figure 1.0-1.

Figure 1.0-1. Fire Scene Photograph

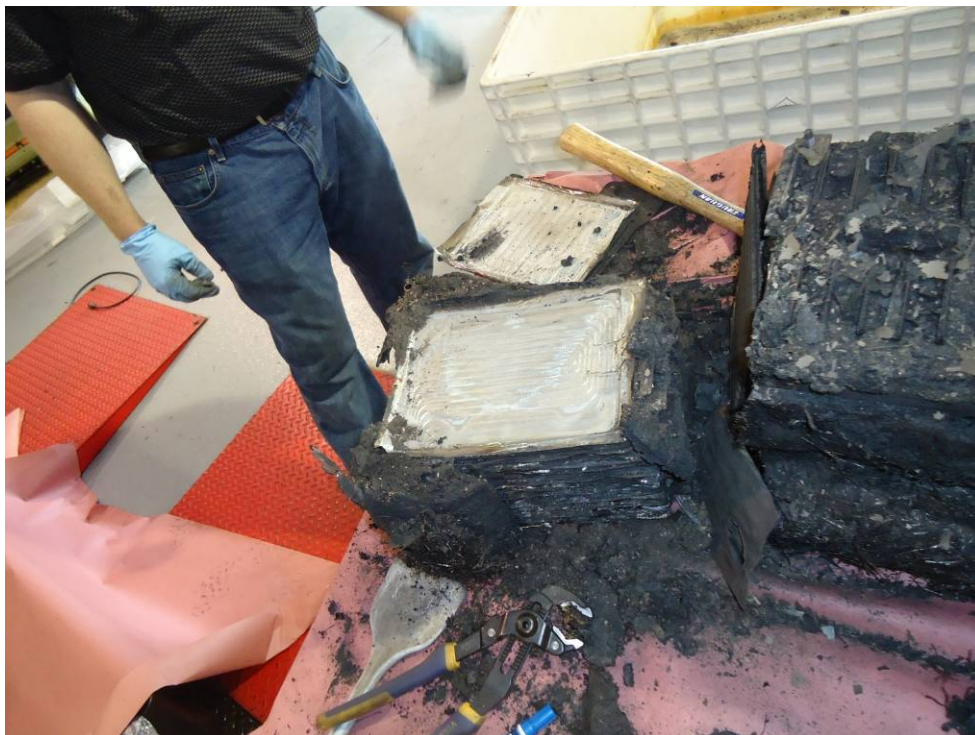
Precautions were taken to prevent additional damage when removing the cells and fins from the module. However, to start the removal process, a saws-all was required to cut away the cooling lines and the support rods that run along the bottom of each module. A photograph showing the disassembly of the battery is provided as Figure 3.3-4.

Figure 3.3-4. Overall Battery Condition Photograph

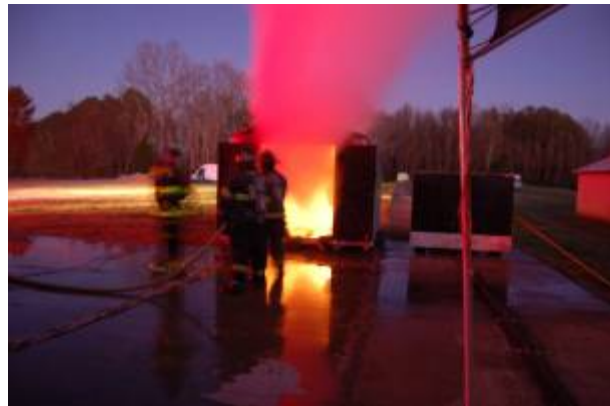
Figure 7.5 – Photograph Showing Final Attack on Fire

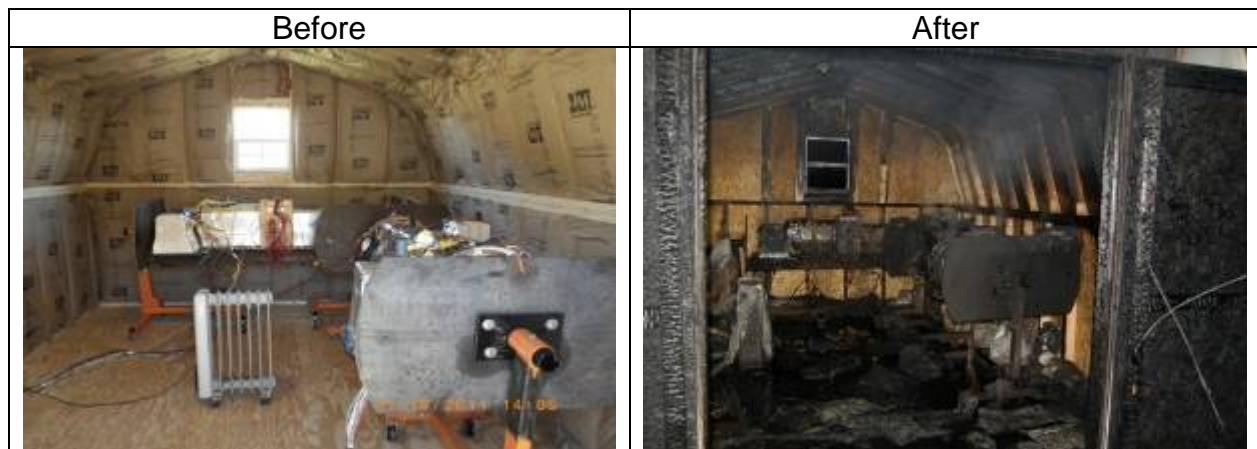
Figure 7.6 – Photograph Showing the Contents of the Shed Before and After the Event

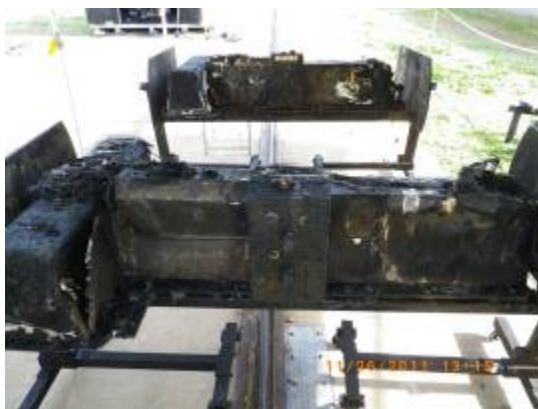
As a general statement, a significant amount of the combustible materials in both batteries were consumed during the fire. A photograph showing two batteries is provided as Figure 7.8.

Figure 7.8 – Photograph of Batteries from Tests 1 and 2 (Battery from Test 2 is closest to the photographer)

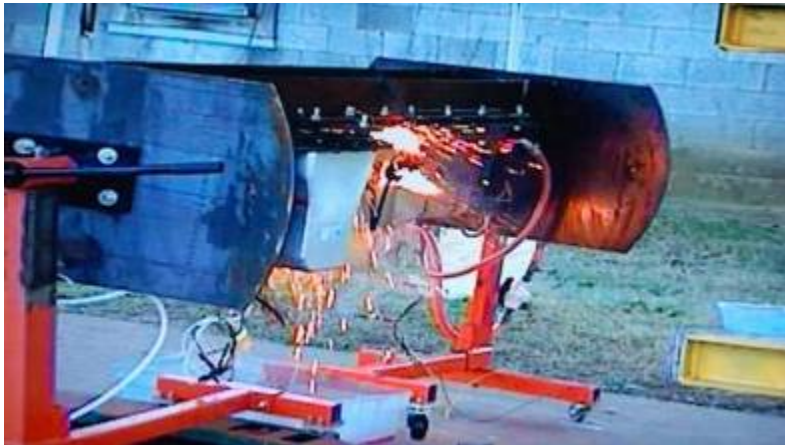
The event occurred during the rotation of the battery after the impact (about an hour after the impact). The battery was x-rayed after the impact. The battery pack was then tilted about 1 degree downward (the front end of the battery was 1 degree lower than the back end) to simulate the conditions during the rotation at MGA in May. The battery was then rotated at 90 degree increments (toward the passenger side) and held at that orientation for five minutes prior to continuing the rotation. The battery was upside-down at the time of the event. It was estimated that a majority of the coolant was located in the front section of the battery (Module 1) at the time of the event. A photograph of the event is provided as Figure 7.11.

Figure 7.11 – Photograph Showing Flames and Sparks from Test 3 Battery

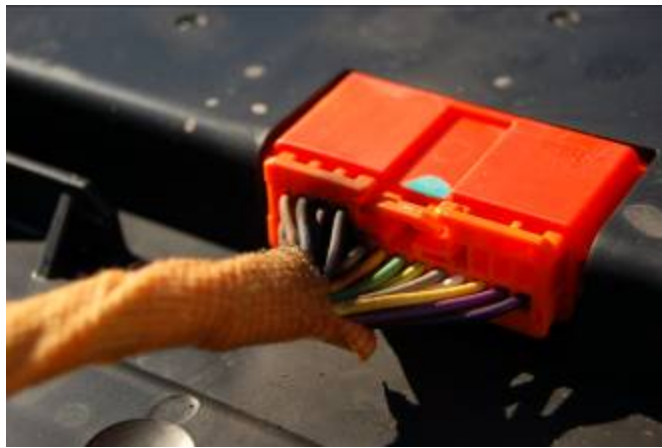
Post test visual inspection of the battery revealed discoloration(brown to black) on the wires and orange jacket leading from the orange connector on the battery to VSTM 3. See photograph at Figure 7.12.

Figure 7.12 Discoloration of wires and orange jacket

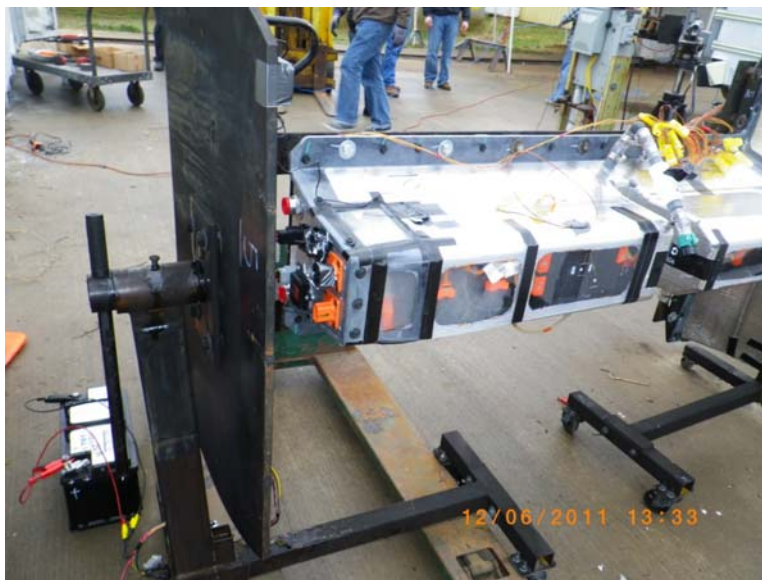
During the rollover portion of the test, between 180 degrees and 270 degrees, the coolant must have submersed the positive and negative terminals located on the driver's side of Module 1 causing rapid electrolysis of the coolant. A vigorous boiling sound could be heard as the battery was rotated through this orientation. The electrolysis abruptly stopped as the battery approached the 270 degree orientation and no other adverse effects were observed. A photograph showing the battery at the 270 degree mark is provided as Figure 7.13. Smoke can still be seen in the area where the shorting and electrolysis is believed to have occurred.

Figure 7.13 Test 5 with the Battery at the 270 degree orientation

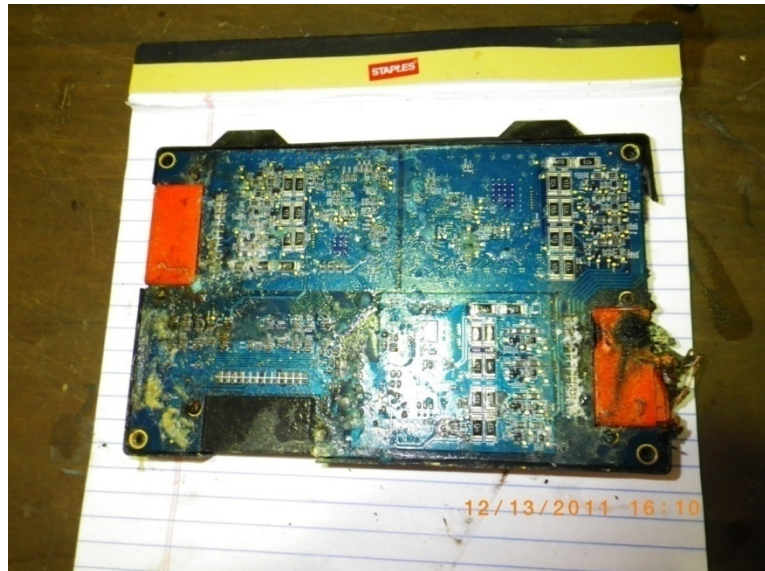
The forensic inspection of the cells was consistent with the fire originating at the connection between the voltage monitoring system bus bar and the cable for VTSM 3. Specifically, there was no damage to any of the cells other than directly under the connector and there was no damage to VTSM 3. A photograph of VTSM 3 is provided as Figure 7.16.

Figure 7.16 VTSM 3 – No Apparent Fire Damage
